SEISMIC ASSESSMENTS FOR THE BEAVERTON SCHOOL DISTRICT

(VOLUME 1 OF 4)

KPFF PROJECT No. 10021800125

APRIL 12, 2019

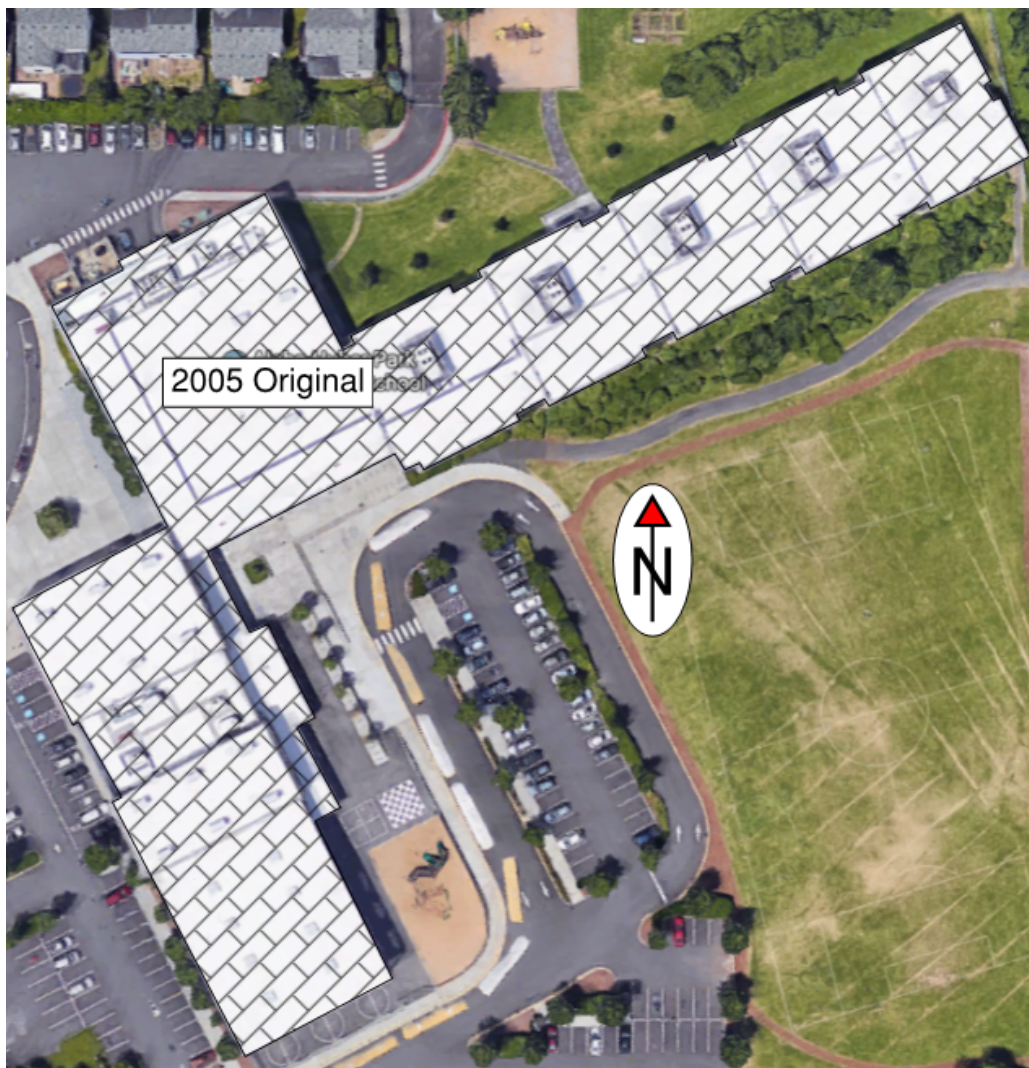
The 2005 school has two wings. The northern wing consists of an administration area, commons area, and classrooms across a two-story structure. The southern wing has a gymnasium and outdoor covered play area. Gravity elements are made up of steel framing with brick veneer at the northern wing. Reinforced masonry walls with steel roof joists support gravity loads at the gymnasium area. Foundations consist of reinforced concrete strip footings at the exterior and column footings at all interior and exterior columns. The floor system consists of a reinforced concrete slab-on-grade with connections back to foundations. The lateral force-resisting system consists of an SCBF system and reinforced masonry walls at each wing respectively. The roof diaphragm for each wing consists of normal and acoustical metal decking. The second floor diaphragm is composite metal deck with reinforced concrete topping.

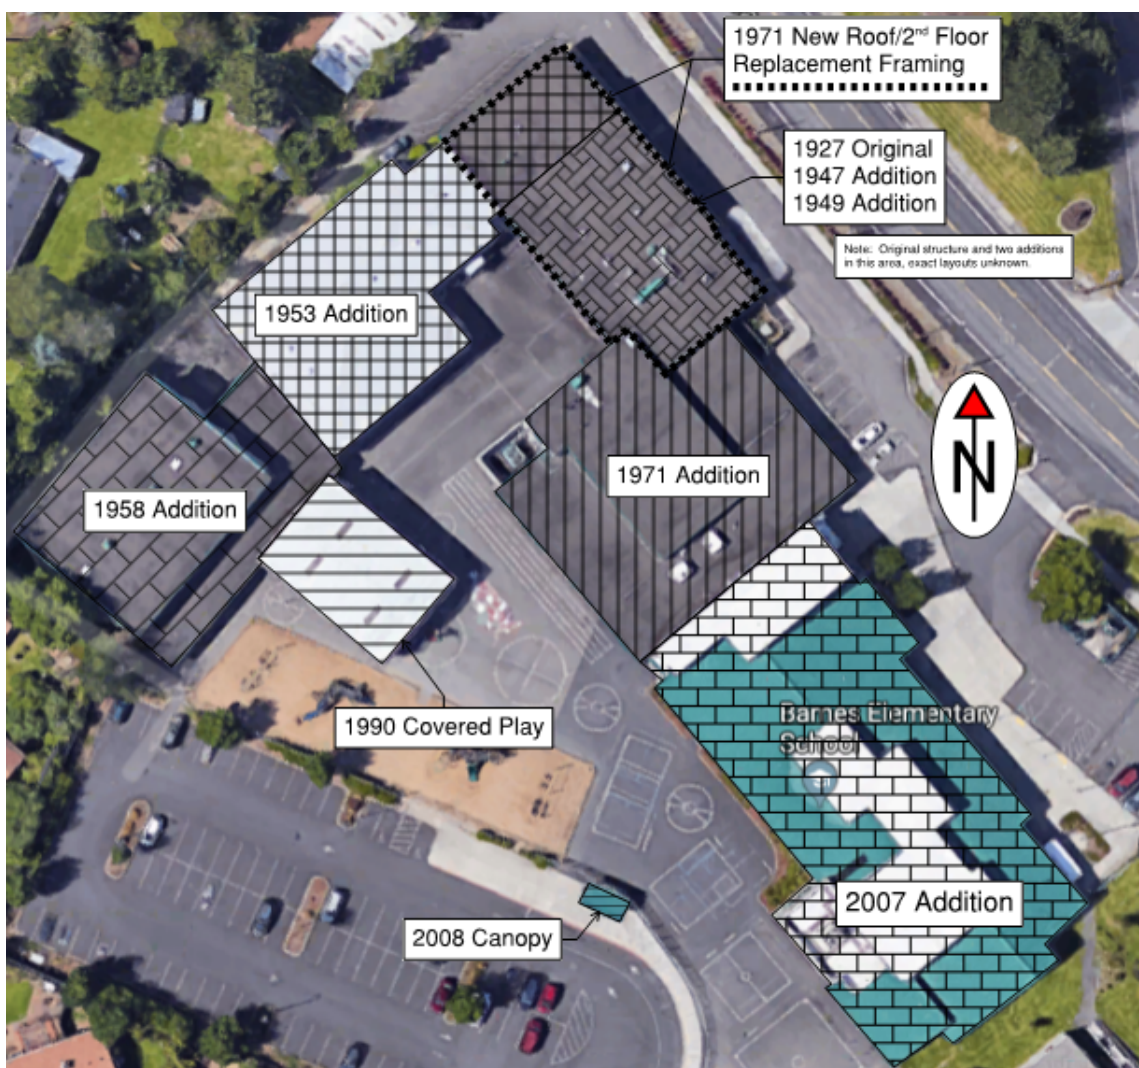
The original two-story structure was built in 1927 with two small additions added in 1947 and 1949, respectively. There are no drawings available for the 1927 initial construction. The 1947 and 1949 construction phases do not have clear existing drawings and there is no clear separation of building years through visual observations. Each addition was constructed with wood framed walls at the exterior with stucco siding. The first floor and roof are framed with wood construction including glulam beams with diagonal sheathing. Exterior concrete foundation walls are used around the lower level as bearing and retaining walls. A concrete slab-on-grade is used at the lower floor with shallow concrete foundations. The roof diaphragm was originally wood decking with a plywood upgrade, and the roof framing replacement occurred during in the 1971 addition.

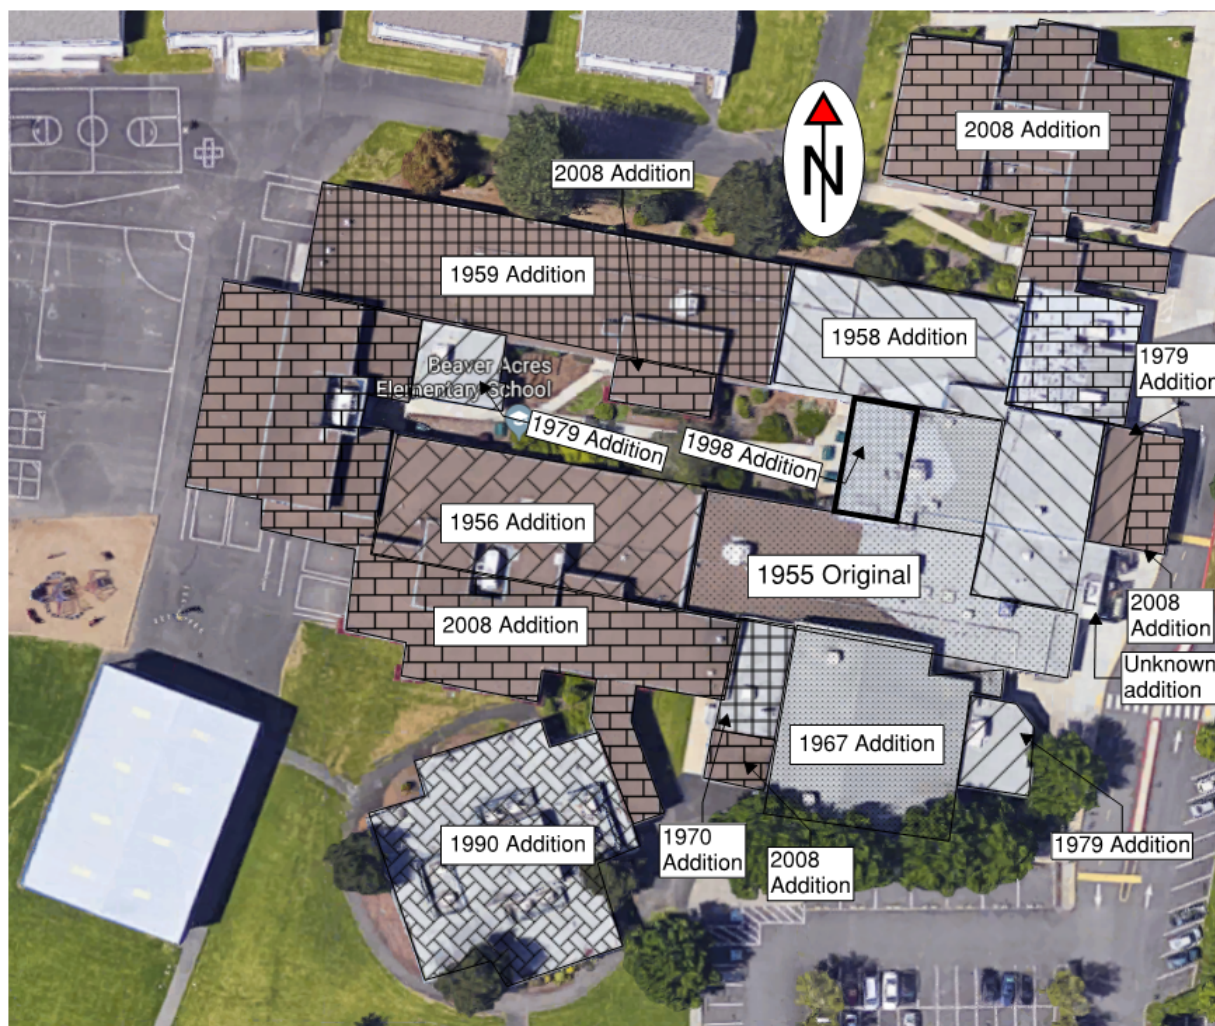
The original 1955 building is similar to the 1956, 1958, 1959, 1967, and 1970 additions. These sections have a concrete slab-on-grade with concrete shear walls, concrete spread footings, a concrete slab-on-grade, and a wood roof diaphragm. The 1955, 1956, 1958, 1959, and 1967 buildings are constructed with reinforced concrete shear walls that extend from the foundation to the diagonally sheathed roof. In the classrooms of the main building the north wall is composed of glass windows and steel supports, and the south wall includes an exterior concrete shear wall. There is a roof overhang past the south wall that served as a covered play area. This overhang was later enclosed during the 1970 additions with reinforced CMU walls and window storefronts. In addition to filling in the covered play area, the 1970 addition also included a locker room that is connected to the original 1967 gymnasium. The locker room is constructed of concrete shear walls, partial height internal CMU partitions, and a concrete slab-on-grade. The roof diaphragm is made up of diagonal sheathing.

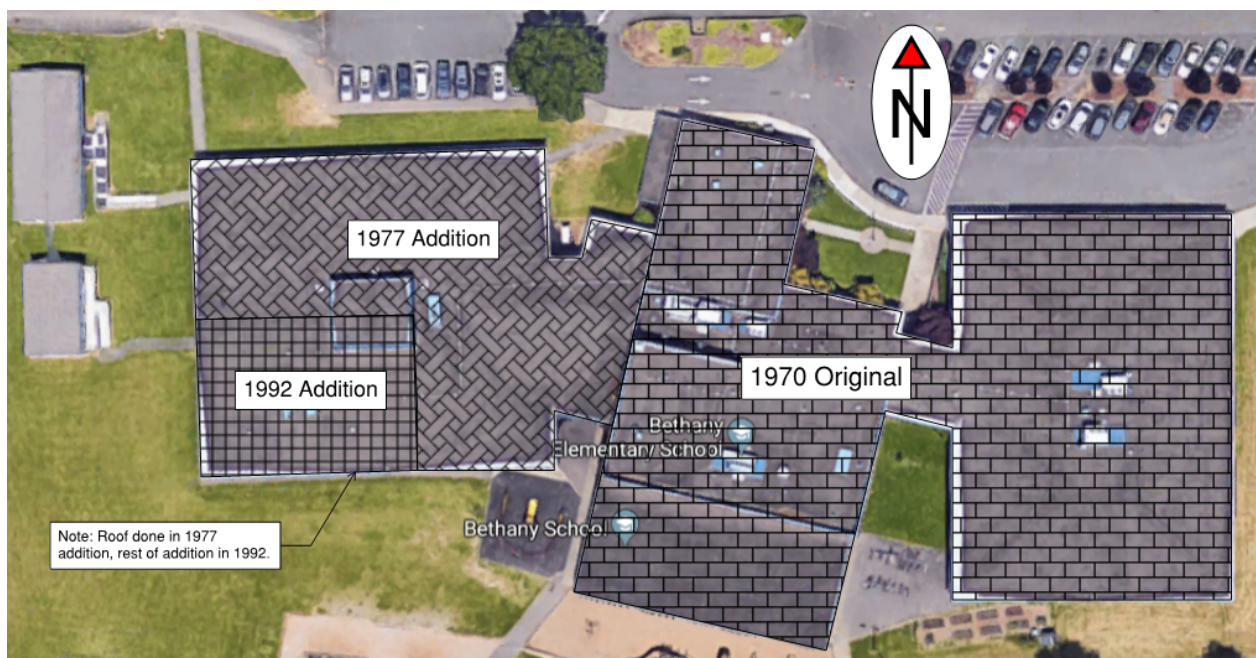
The original 1970 building construction consists of two wings with classrooms, a gymnasium, a kitchen/cafeteria area, and bathrooms. Structural elements include reinforced masonry bearing walls with steel tube columns to support the wood framing at the roof. The lateral force-resisting system consists of exterior reinforced masonry shear walls. The roof diaphragm is made up of 2 inch tongue & groove decking with plywood sheathing.

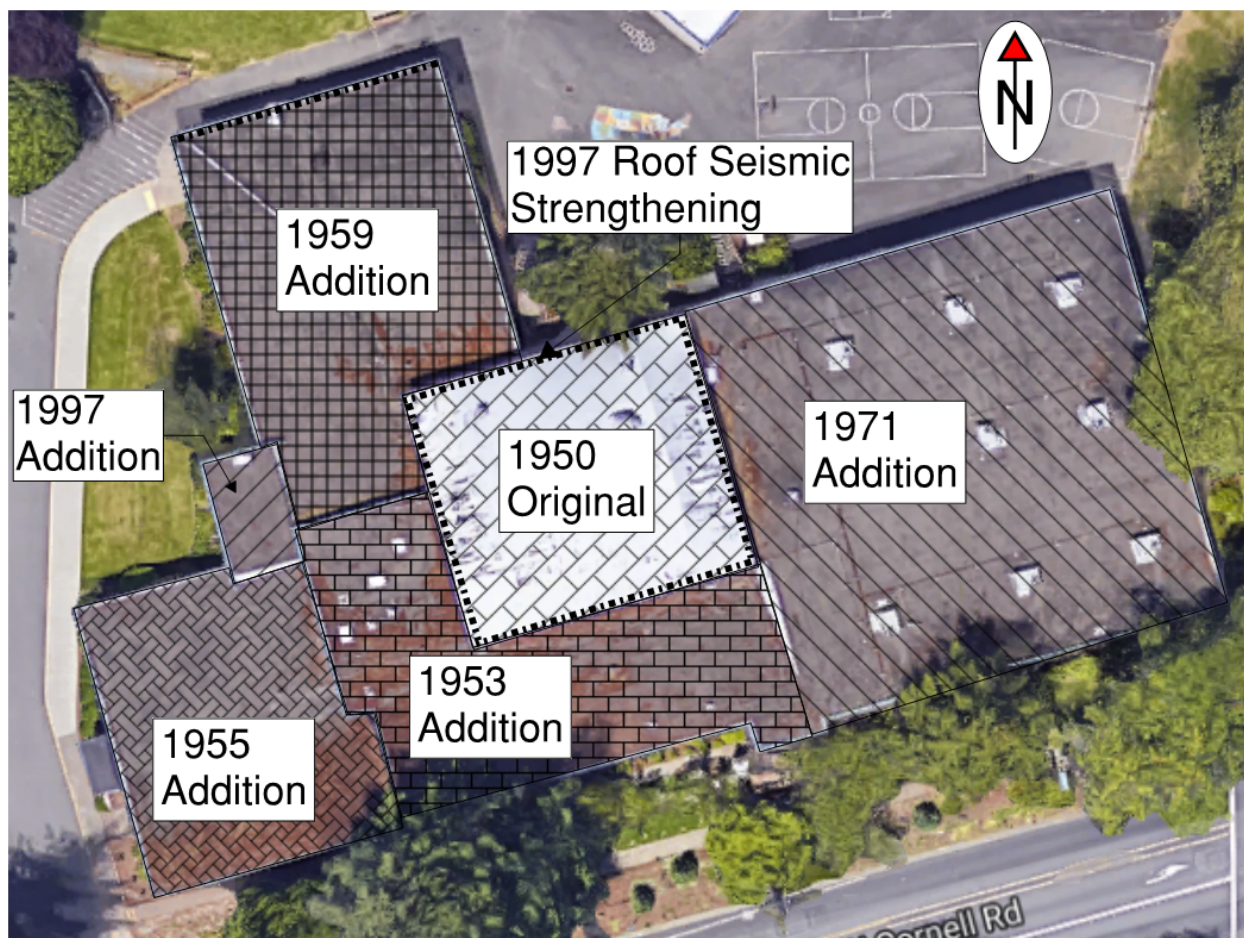
The 1950 gymnasium building was an addition to the now demolished original structure. The gymnasium was built with reinforced concrete slab-on-grade and reinforced concrete continuous footings which support the wood shear walls. Diagonal roof sheathing is supported by wood purlins which span between glulam bowstring trusses. There was a lateral roof upgrade in 1997 which provided connections from the roof diaphragm to the wood shear walls for in-plane lateral forces.

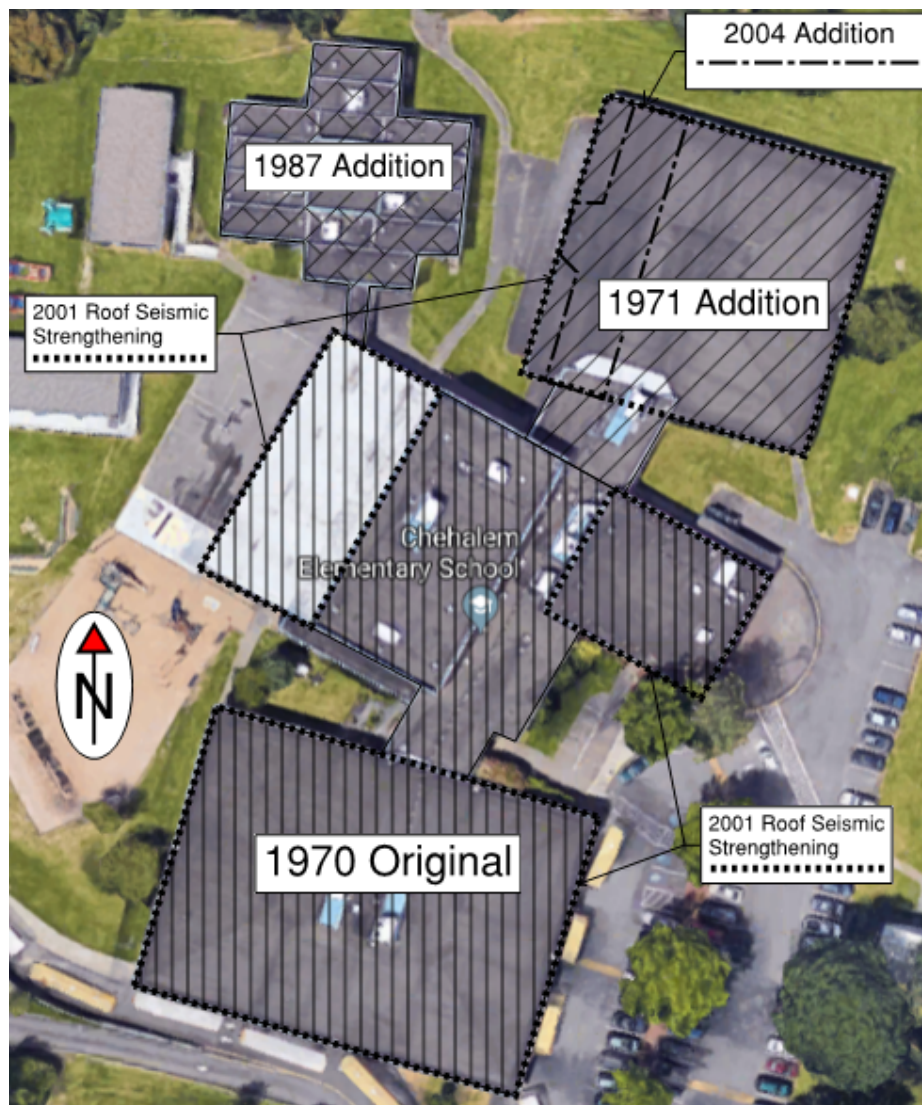
The original 1970 building construction consists of two wings with classrooms, a gymnasium, a kitchen/cafeteria area, and bathrooms. Structural elements included masonry bearing walls with steel tube columns to support the wood framed gravity framing at the roof. The floor and foundation system supporting these elements is a reinforced concrete slab-on-grade and shallow foundations. The lateral force-resisting system is comprised of reinforced giant brick masonry shear walls at the exterior and some interior locations. The roof diaphragm of the original building consists of 2x decking with a potential plywood diaphragm, much of the original roof diaphragm was strengthened with new plywood decking in the 2001 roofing upgrade.

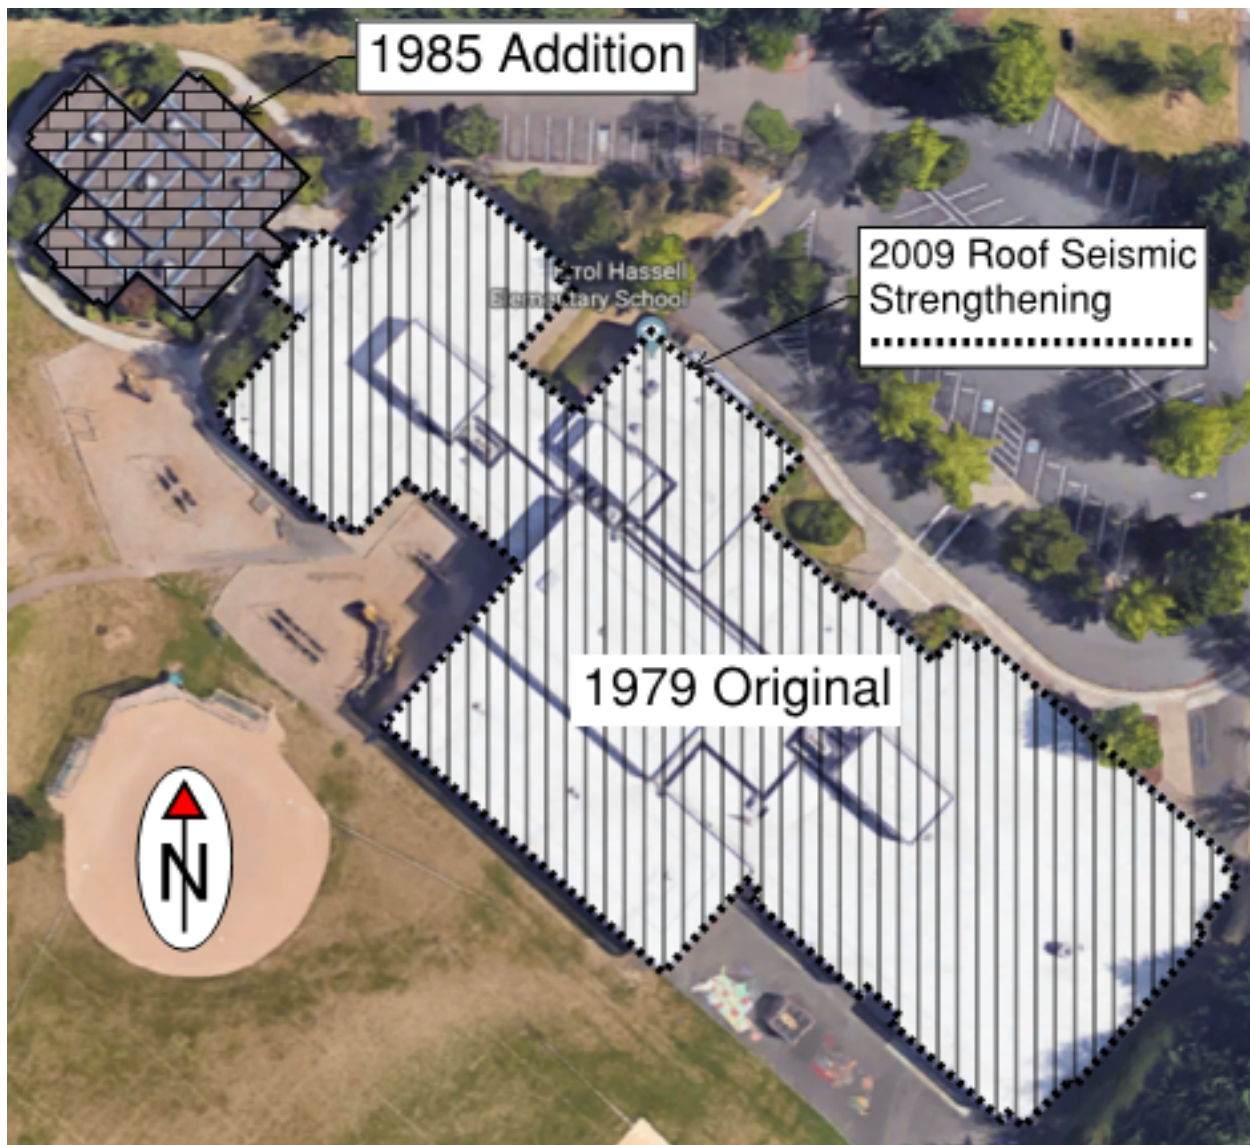
The 1979 original structure includes a classroom wing, cafeteria, bathrooms, administration area, and a gymnasium. The gravity system includes the exterior precast tilt-up walls as well as interior steel tube and wood post columns. The roof framing consists of wood beams, except at the gymnasium where the roof is framed with steel joists. The roof diaphragm is made up of three different materials. The majority of the building has a plywood roof diaphragm, while the gymnasium has an acoustical metal deck diaphragm, and the covered play area has a 3 inch straight board decking diaphragm. The lateral force-resisting system consists of the exterior precast walls.

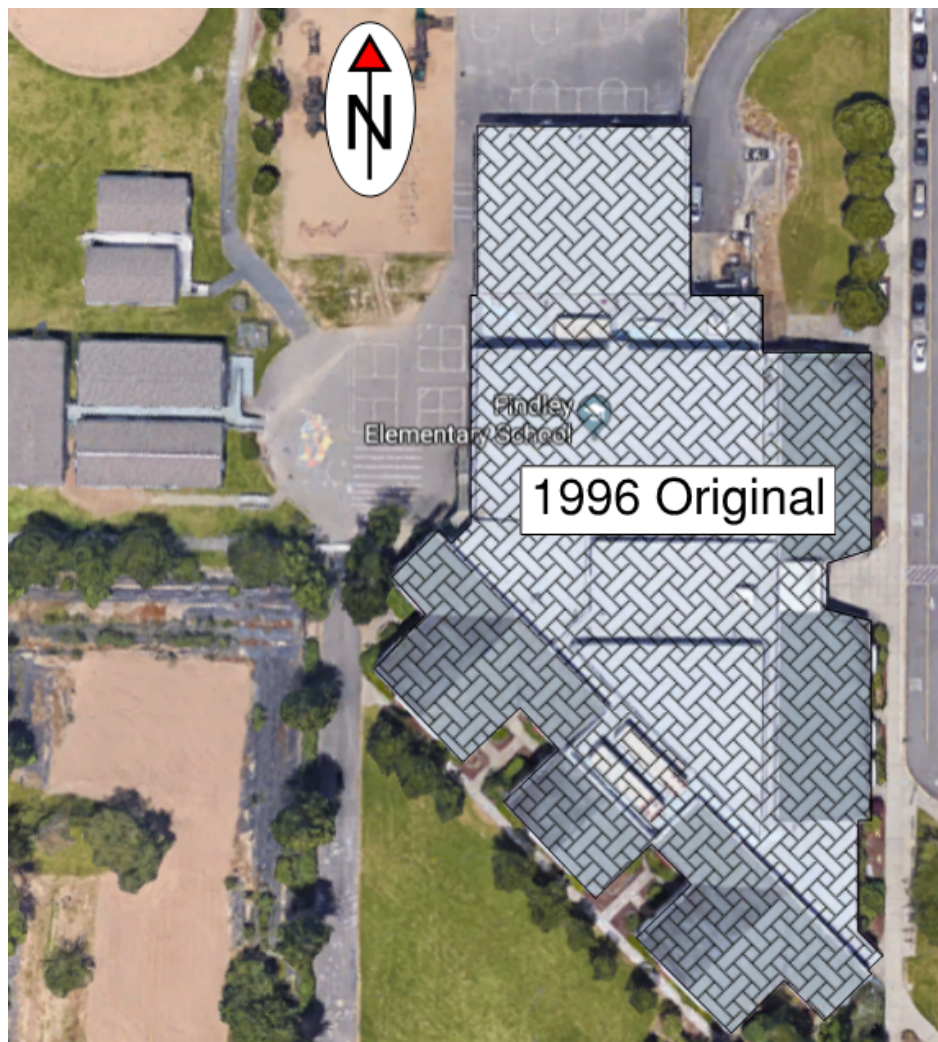
The school is a two-story structure with classrooms, gymnasium, cafeteria, covered play area, and large central open library. The vertical gravity system is composed of steel tube and pipe columns holding up primarily glulam beams at the second floor, and roof level with some wood joists used as secondary support. The structure has a foundation system consisting of shallow reinforced concrete foundations and a reinforced concrete slab-on-grade floor which has direct connections to the foundations. Wood trusses and glulam beams are used to support the roof decking. A few large portions of roof framing at the southwest side are sloped while the remaining roof is flat. Plywood decking is used on the roof and at the second floor which act as the building diaphragm to move lateral loads into the wood framed shear walls acting as the primary lateral force-resisting system. There is also a large reinforced CMU masonry wall at the covered play exterior wall which provides lateral restraint in the east-west direction. The original seismic design loads are in accordance with UBC Zone 3.

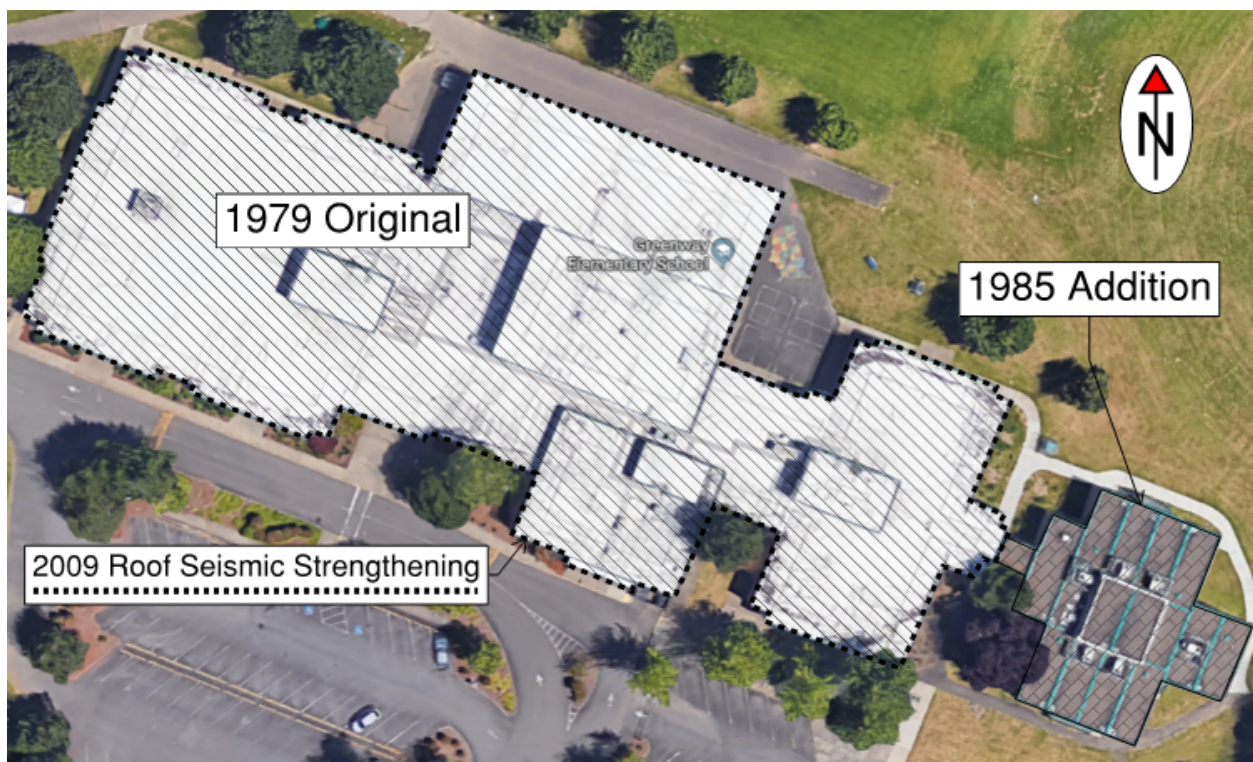
The original 1978 structure includes a classroom wing, cafeteria, bathrooms, administration areas, and a gymnasium. The gravity system uses exterior precast tilt-up walls, interior steel tube columns, and wood post columns. The roof framing was made up of wood beams everywhere except at the gymnasium, which was built using steel roof joists. The roof diaphragm is made up of three different materials. The majority of the building is plywood decking, the gymnasium roof uses acoustical metal deck, and the covered play area has 3" straight board wood decking.

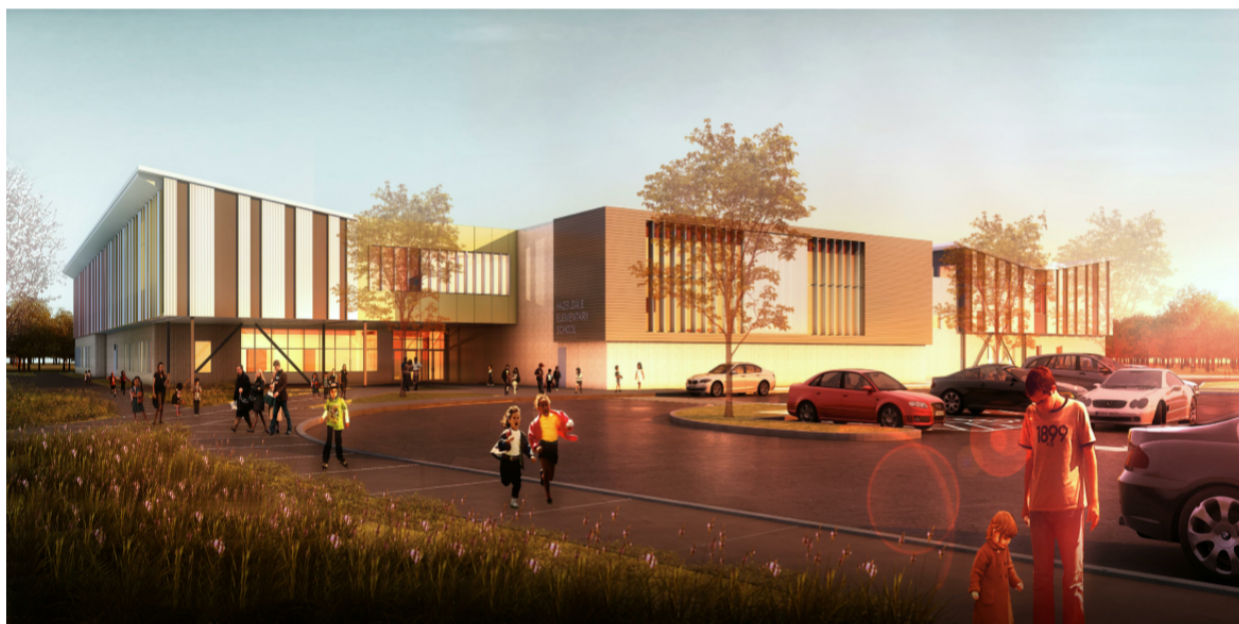
Building Description (separated by construction phases)

This is a new elementary school building constructed in 2018 replacing the older building originally constructed before 1954. This new building includes new classrooms, cafeteria, gymnasium and covered play area. The structure consists of steel framing, precast concrete wall panels and reinforced masonry walls. This building was designed for seismic risk Category IV.

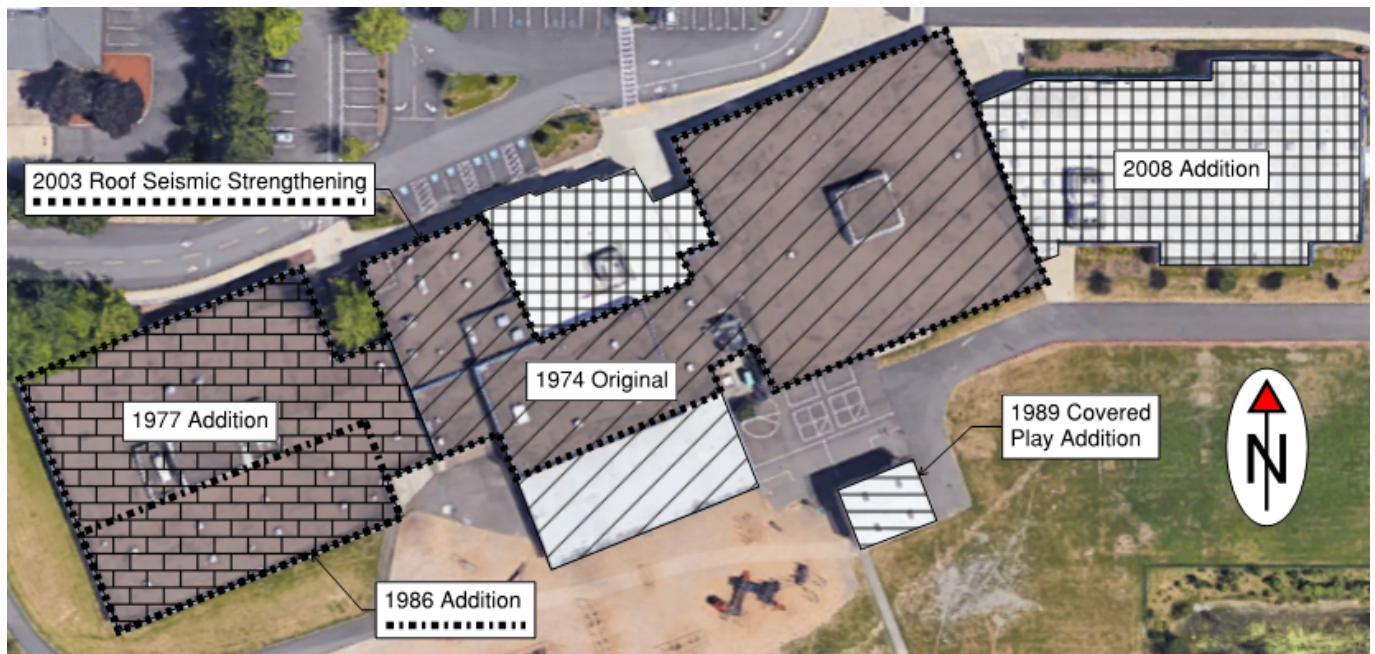
Building Description (separated by construction phases)

The original 1974 building has two separate wings, the first having classrooms and a library. The second wing includes a cafeteria, gymnasium, bathrooms, and administration areas. There is also a covered play area on the southern side of the second wing. Both wings were built with exterior reinforced masonry bearing walls and interior steel and wood columns. These elements are supported by reinforced concrete foundations and slab-on-grade floor system. The foundations are then anchored and connected into the lateral force-resisting system. The lateral force-resisting system uses the exterior masonry shear walls as well as some interior masonry at the second wing. The roof diaphragm is made up of plywood decking. The roof framing supporting the diaphragm are wood glulam beams and joists.

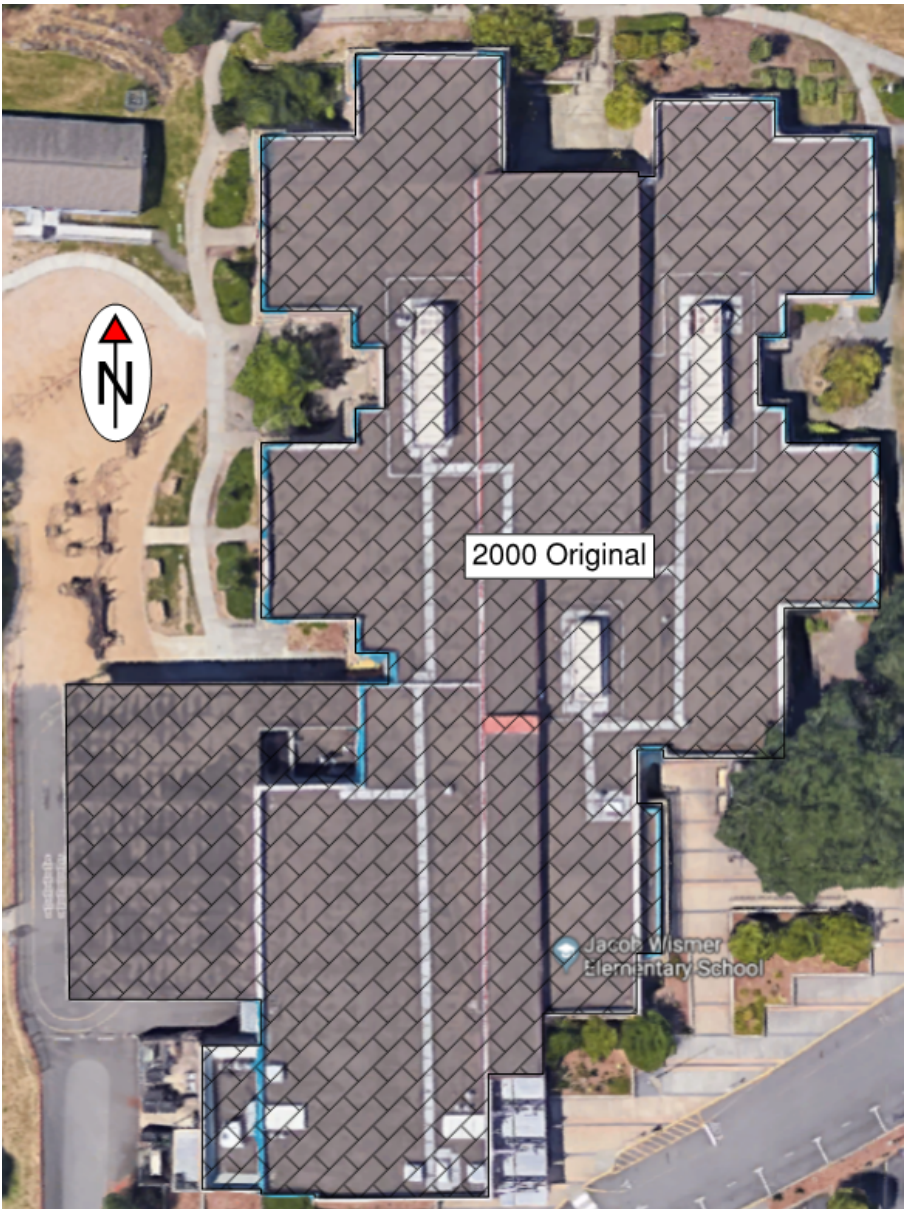
Building Description (separated by construction phases)

This two-story structure includes multiple classrooms, a gymnasium, cafeteria, and covered play area. The primary gravity system for this structure is comprised of wood framed bearing walls and steel tube columns. The roof framing is constructed mainly of wood joists, built-up wood girders, steel joists, and steel beams. There are also various concrete and masonry walls being used as gravity elements. These members support plywood and metal decking that is used at the roof diaphragm. The first floor of the building also contains a plywood diaphragm that connects to the lateral elements. The lateral force-resisting system consists primarily of wood framed shear walls with plywood sheathing.

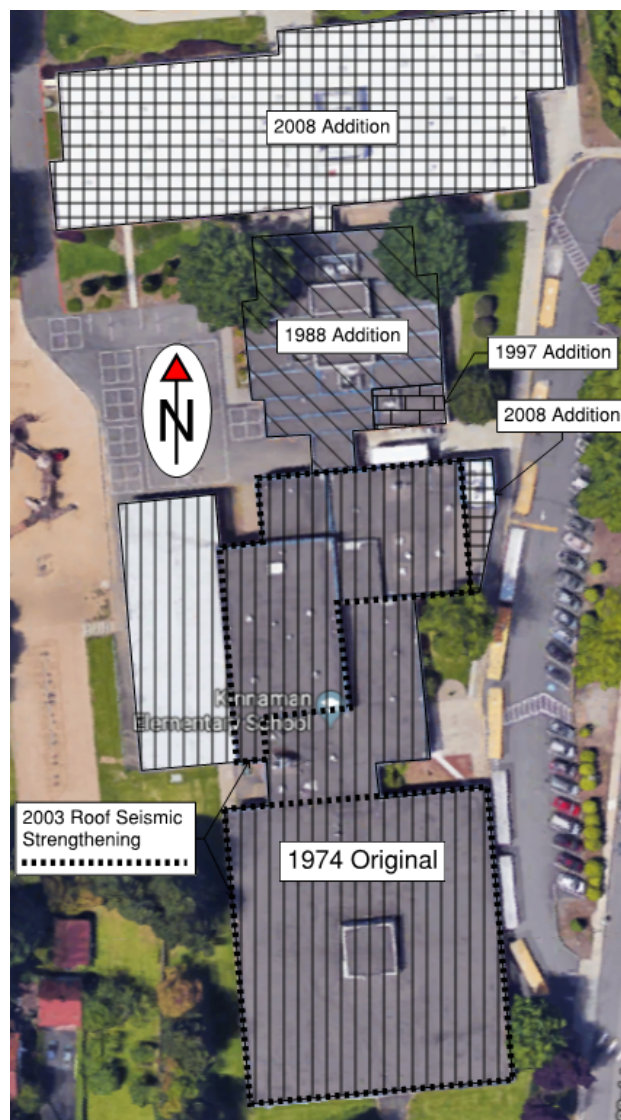
Building Description (separated by construction phases)

The original building includes two separate wings, the first includes classrooms and a library and the second wing includes a cafeteria, gymnasium, bathrooms, and administration area. There is also a covered play area on the western side of the second wing. Both wings were built with exterior reinforced giant brick masonry bearing walls and interior steel and wood columns. These elements are supported by reinforced concrete shallow foundations and a slab-on-grade floor system. The foundations are anchored and connected into the lateral force-resisting system. The lateral force-resisting system uses the exterior masonry giant brick shear walls as well as some interior masonry walls in the northern wing. The diaphragm at the roof level is made up of plywood sheathing across the entire structure, except the covered play area which is straight sheathed wood tongue and groove decking. Wood glulam beam and joist framing is used at the roof level to support the diaphragm.

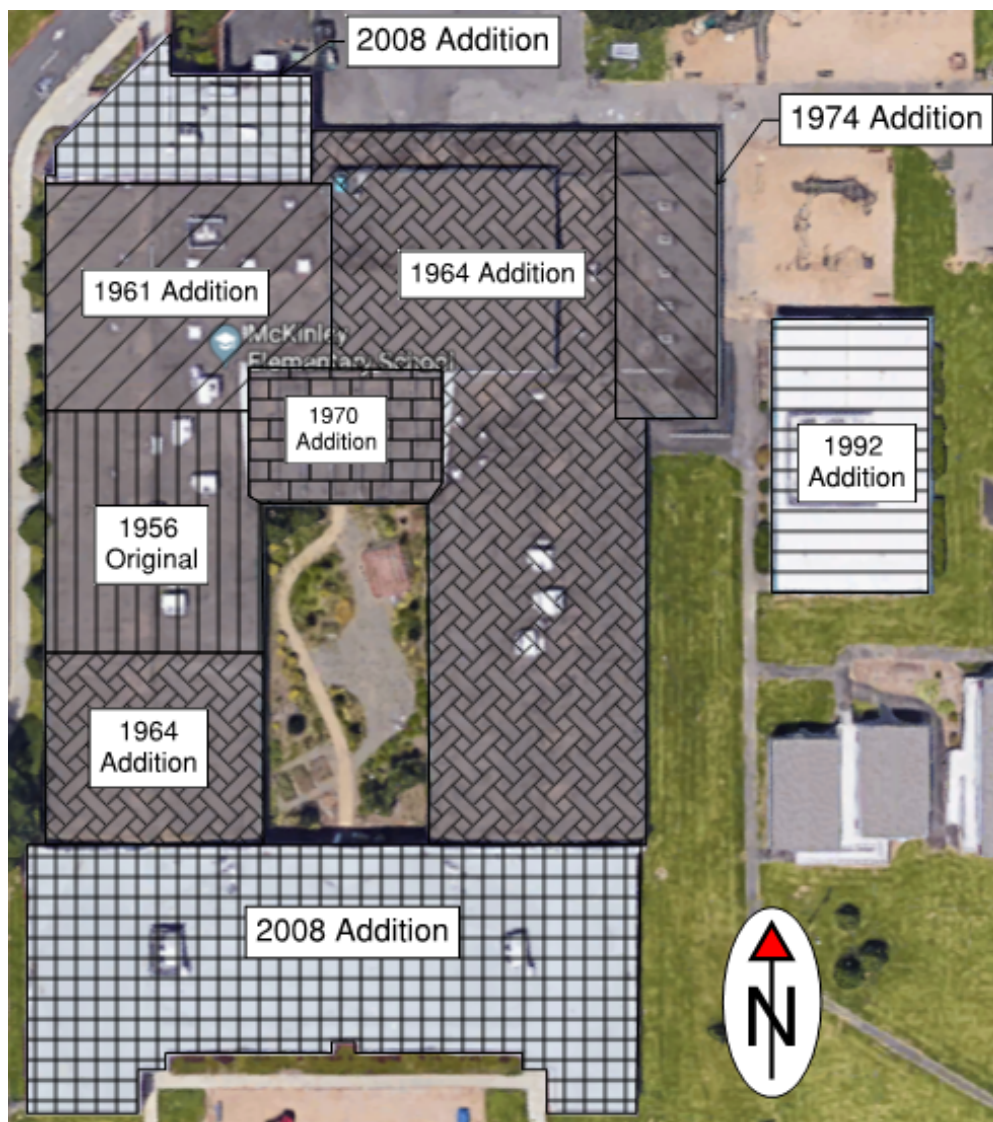
Building Description (separated by construction phases)

The original 1956 structure consists of classrooms, bathrooms, and an outdoor covered play area. This portion of the structure uses wood framed bearing walls and wood posts for the gravity system. The roof system consists of glulam beams supporting a straight sheathed wood decking. The lateral force-resisting system is wood framed shear walls with gypsum board sheathing. The original covered play area was demolished while building the 1961 addition. The roof system is continuous over the covered play area and the rest of the original structure. A reinforced concrete foundation and floor system are used to support all of the above elements; the bearing and shear walls are tied into the foundations. An asphalt floor system was used at the covered play area but then replaced in the 1961 addition. The wood post columns do not have a positive connection and may allow for upward forces to make the structure unstable.

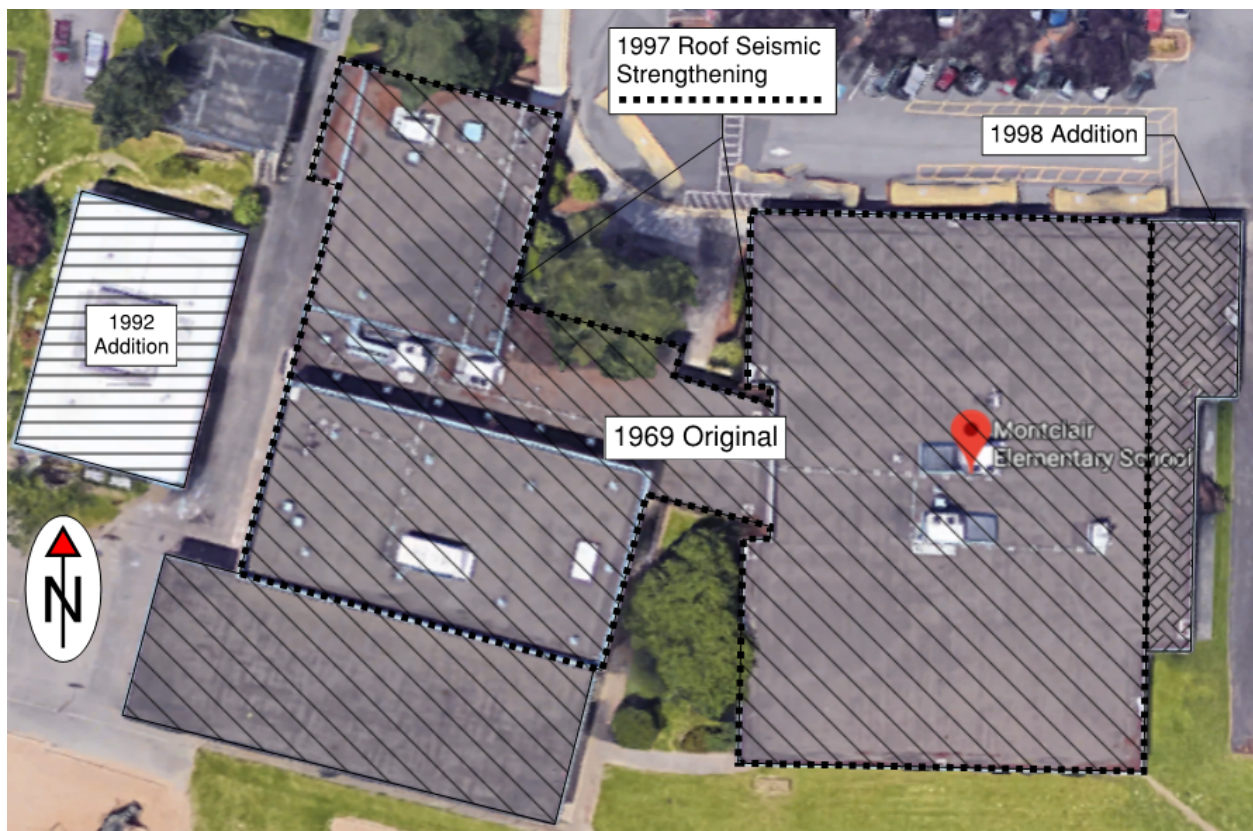
Building Description (separated by construction phases)

The original 1969 building consists of a large classroom wing on the east side and a combination of a cafeteria, gymnasium, administration, and outdoor covered play area on the west wing. The gravity system uses exterior and interior masonry bearing walls along with some interior wood framed walls. These elements were supported by a concrete slab-on-grade floor system and reinforced concrete shallow foundations. Roof framing consists of glulam beams, wood joists, and some steel girders and

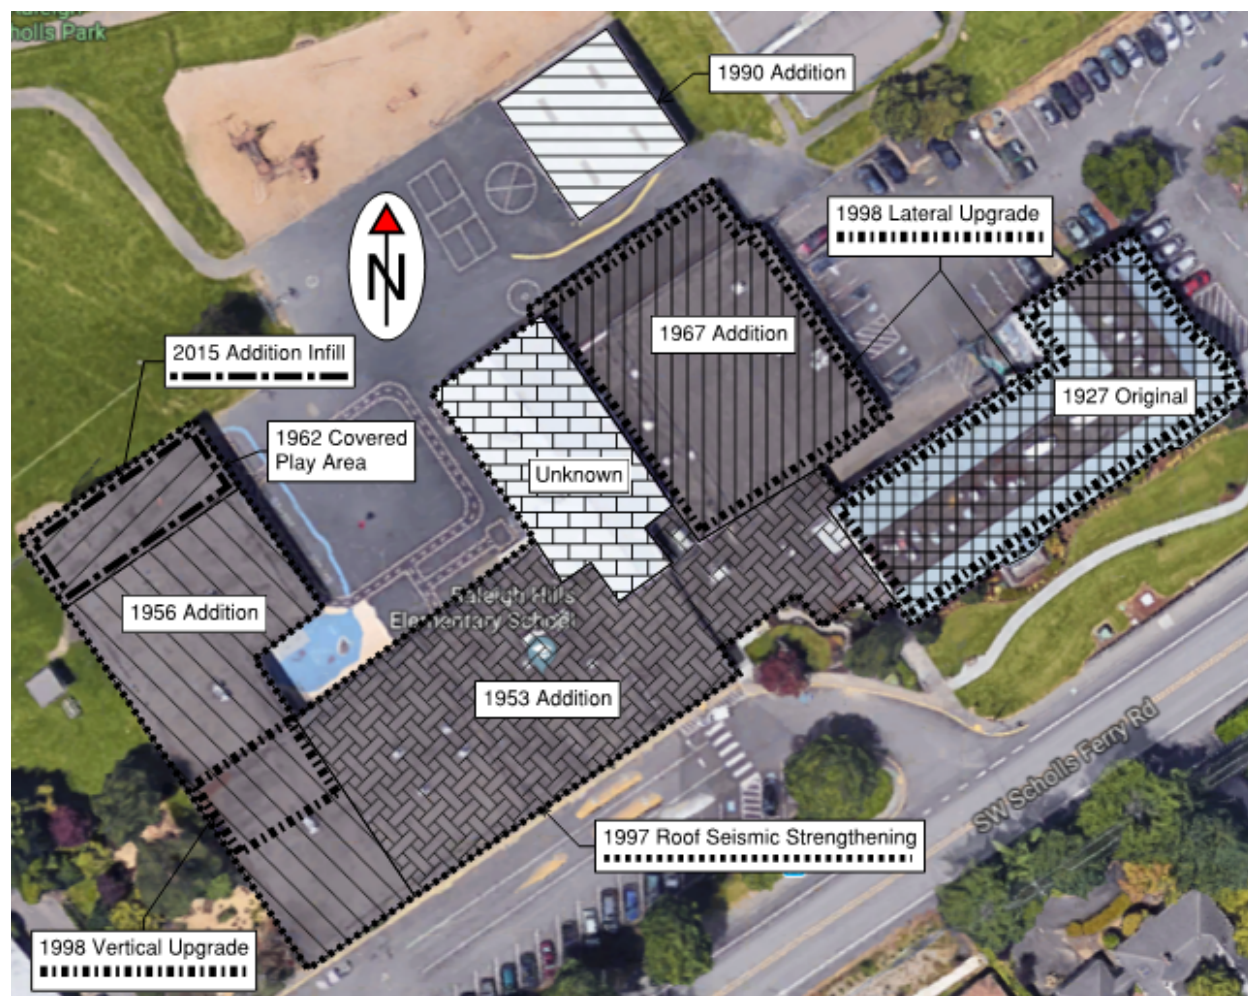
Building Description (separated by construction phases)

The original 1927 building is a two-story structure with multiple classrooms, offices, and a library area. There are no existing drawings available but through visual observations it can be seen that the first story exterior walls are likely unreinforced concrete with wood framed walls at the second story. The brick seen on the exterior is veneer and not loadbearing, but also does not appear to have proper tieback to the structure. The original sloped roof structure appears to be a straight board wood decking diaphragm.

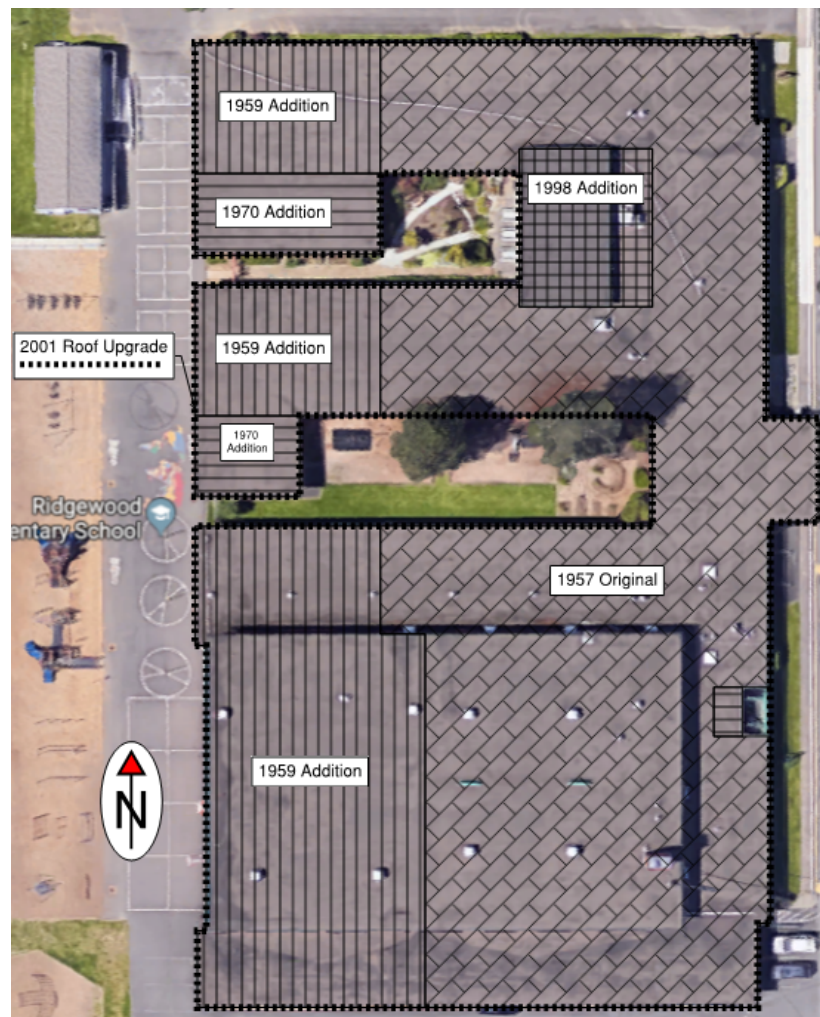
Building Description (separated by construction phases)

The original 1957 building consists of multiple classroom wings, an administration area, and a cafeteria/gymnasium with an attached covered play area. The structure is primarily built using concrete frames at the exterior with unreinforced masonry infill, and interior wood and brick walls. The roof framing is mainly wood glulam beams with tongue and groove decking for the diaphragm. The lateral force-resisting system consists of the concrete frames with masonry infill at the gymnasium and interior wood framed walls at the classrooms. The foundations are reinforced concrete shallow foundations and the floor is a reinforced concrete slab-on-grade. Neither the foundations nor floor system are tied into the exterior walls. The lateral force-resisting system at the classrooms consist of wood framed shear walls was not adequate to provide lateral resistance. A new lateral force-resisting system was added in the 1998 addition that provided lateral support at the lower classroom areas.

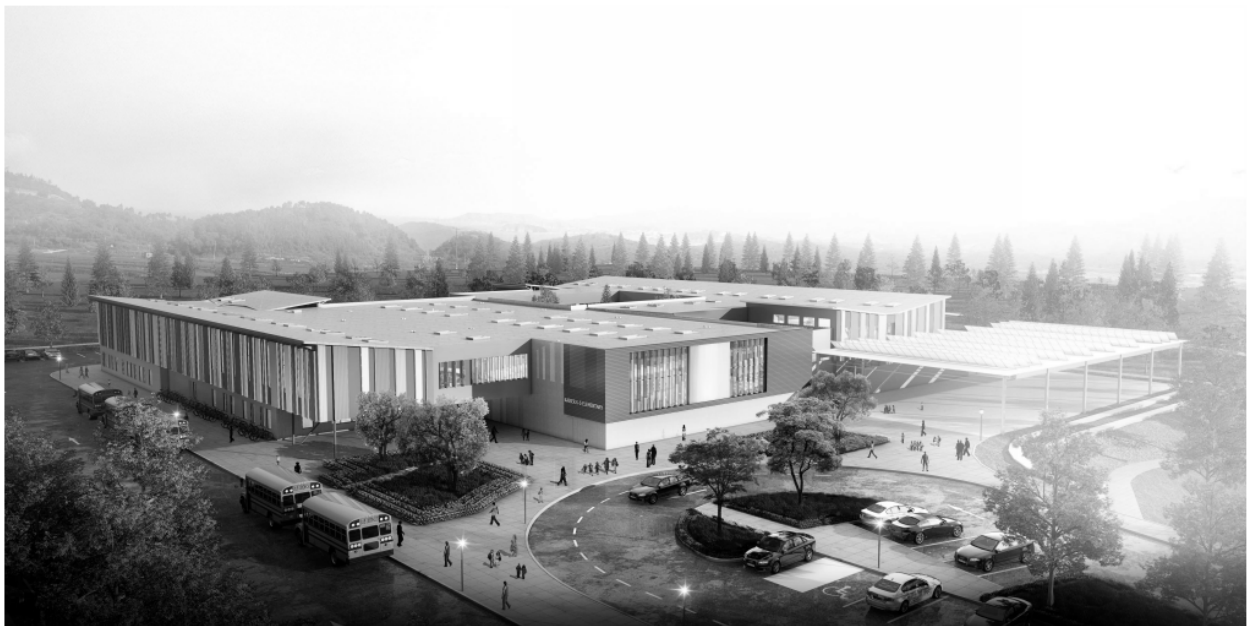
Building Description (separated by construction phases)

The 2017 school includes classrooms, cafeteria, gymnasium and covered play area. The structure consists of steel framing, precast concrete wall panels and reinforced masonry walls. This building was designed for seismic risk Category IV.
