SEISMIC ASSESSMENTS FOR THE BEAVERTON SCHOOL DISTRICT

(VOLUME 1 OF 4)

KPFF PROJECT No. 10021800125

APRIL 12, 2019

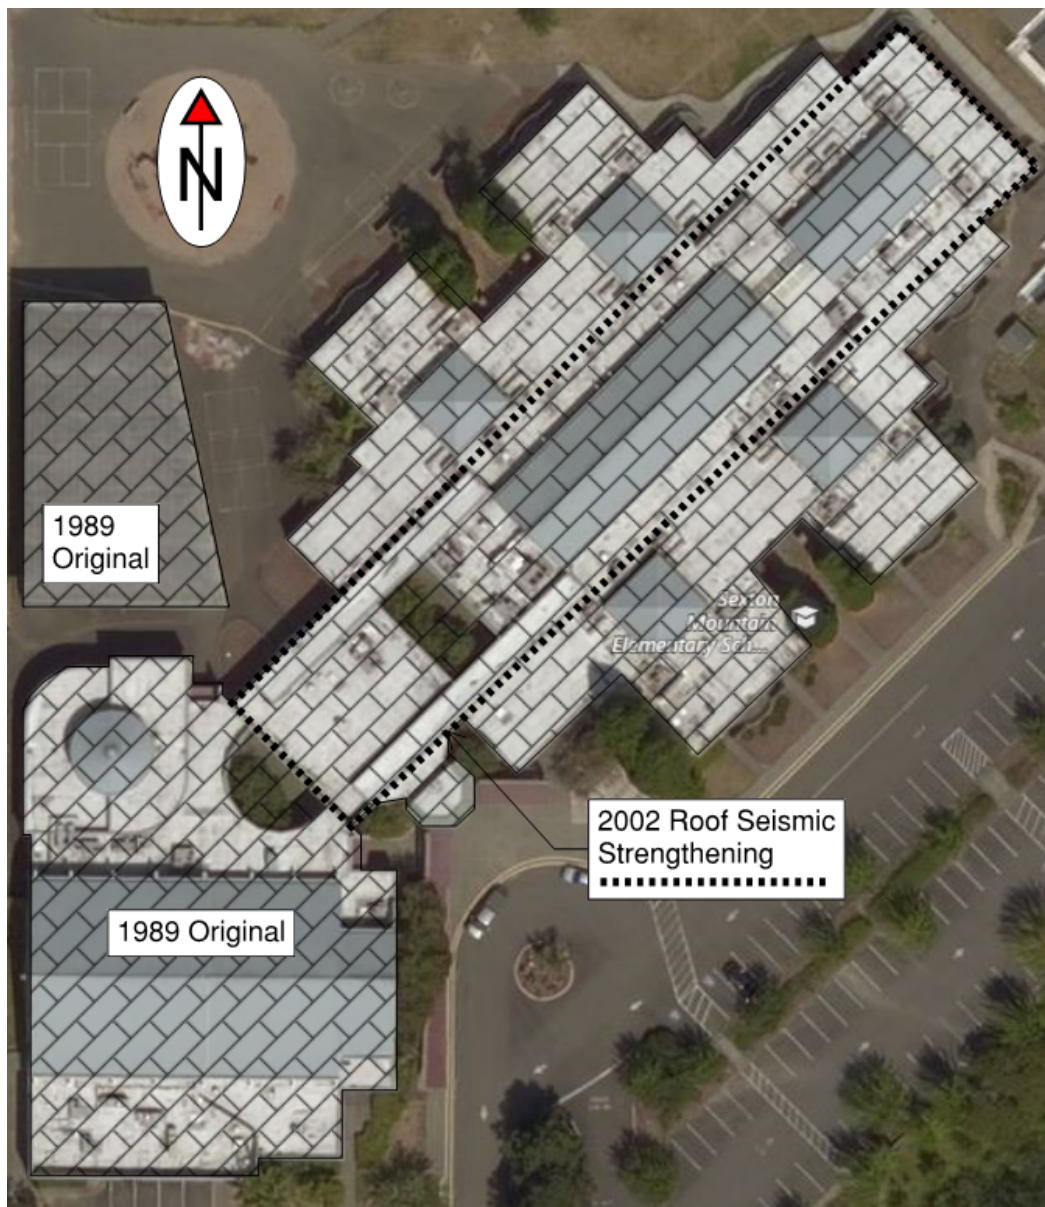
Building Description (separated by construction phases)

The structure consists of both perimeter and interior wood shear walls and some interior reinforced CMU shear walls. Interior shear walls are well distributed throughout the structure. However, plywood diaphragms span more than 40 ft in some cases. Foundations are typical strip and isolated concrete footings with concrete stem walls that extend up to meet either CMU or wood walls at the building perimeter. The floor structure is reinforced concrete slab-on-grade on the middle portion of the building, with direct connection to foundation stem walls. The east and west portions of the building consist of wood framing (with crawl space) supported on isolated footings and perimeter strip footings.

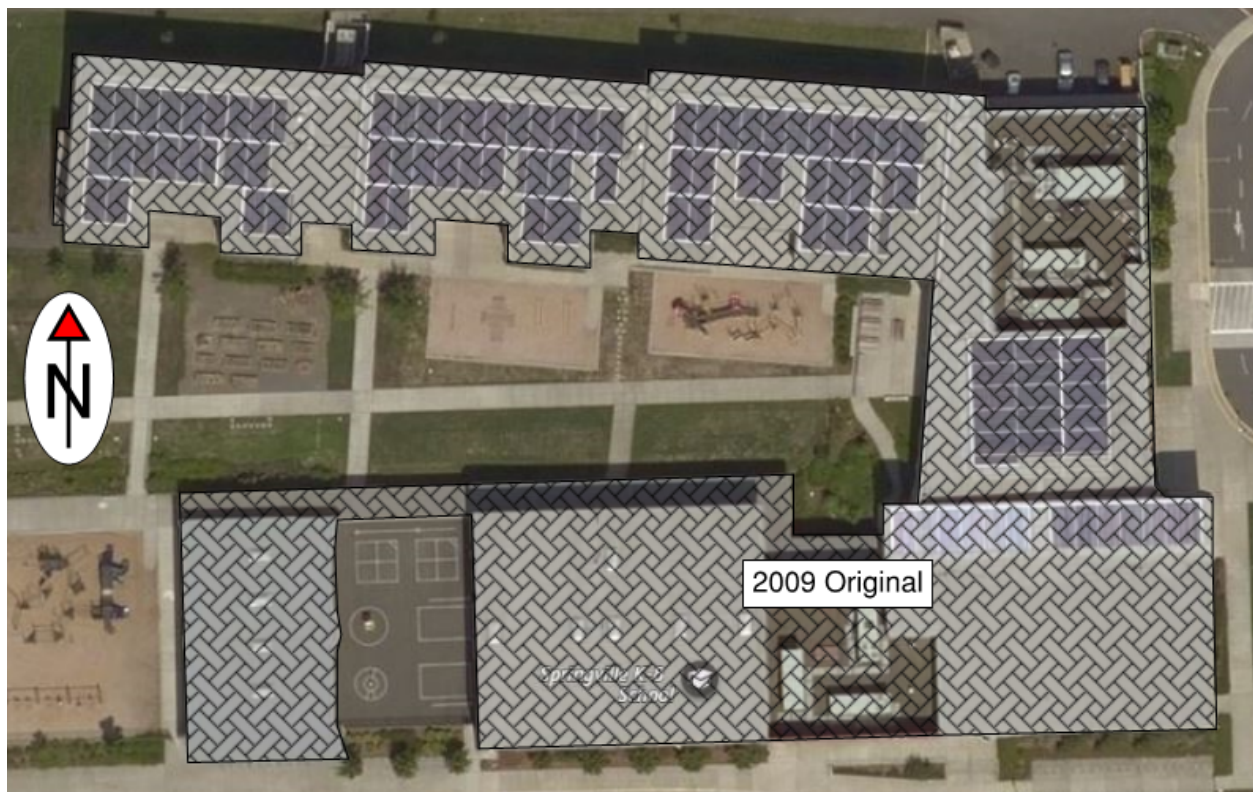
Building Description (separated by construction phases)

The school, built in 2009, includes three distinct areas: a west classroom wing, a main building (east classrooms, commons, administration and stage), and gymnasium with an adjacent covered play area (designed by others). The gravity system is made up of steel framing at the west classroom wing and main building areas, while tilt-up concrete walls with steel open-web roof joists support gravity loads

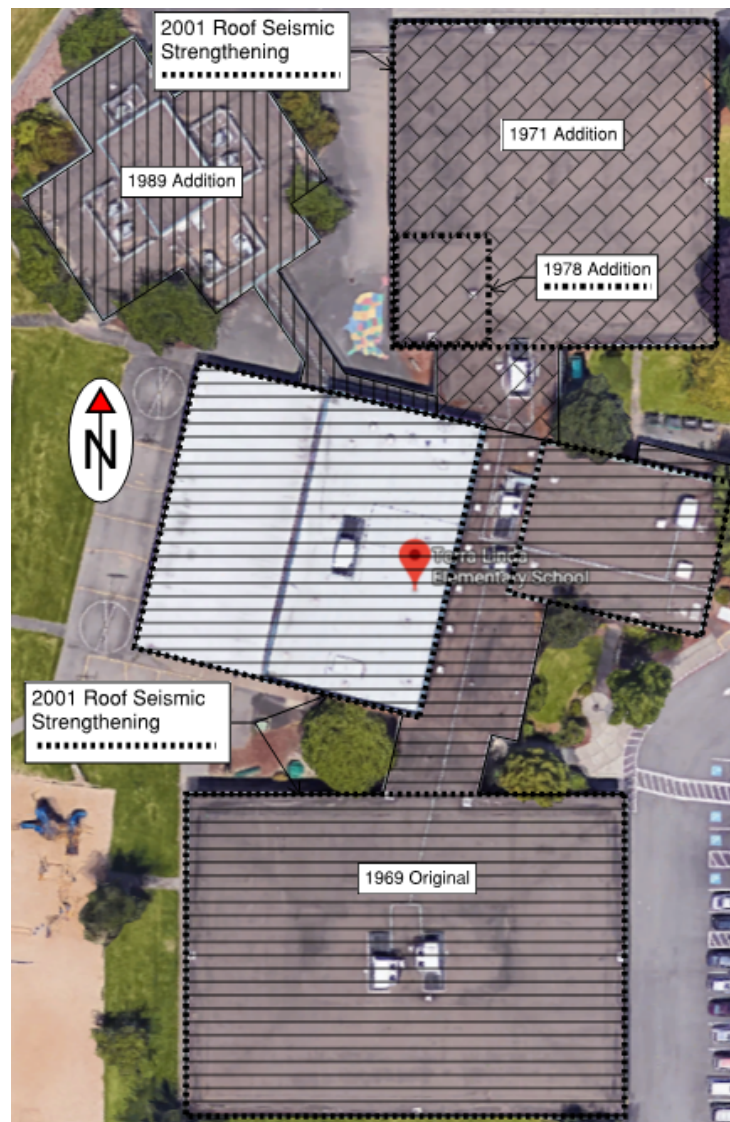
Building Description (separated by construction phases)

The original building area consists of two wings with classrooms, a gymnasium, a kitchen/cafeteria area, and bathrooms. Structural elements included masonry bearing walls with steel tube columns to support the wood framing at the roof. The floor and foundation systems are reinforced concrete slab-on-grade and shallow foundations. The lateral force-resisting system is reinforced giant brick masonry at the exterior and some interior walls. The roof diaphragm of the original building consists of 2x decking with a plywood overlay. Much of the original roof diaphragm was replaced with new plywood decking in the 2001 roofing upgrade.

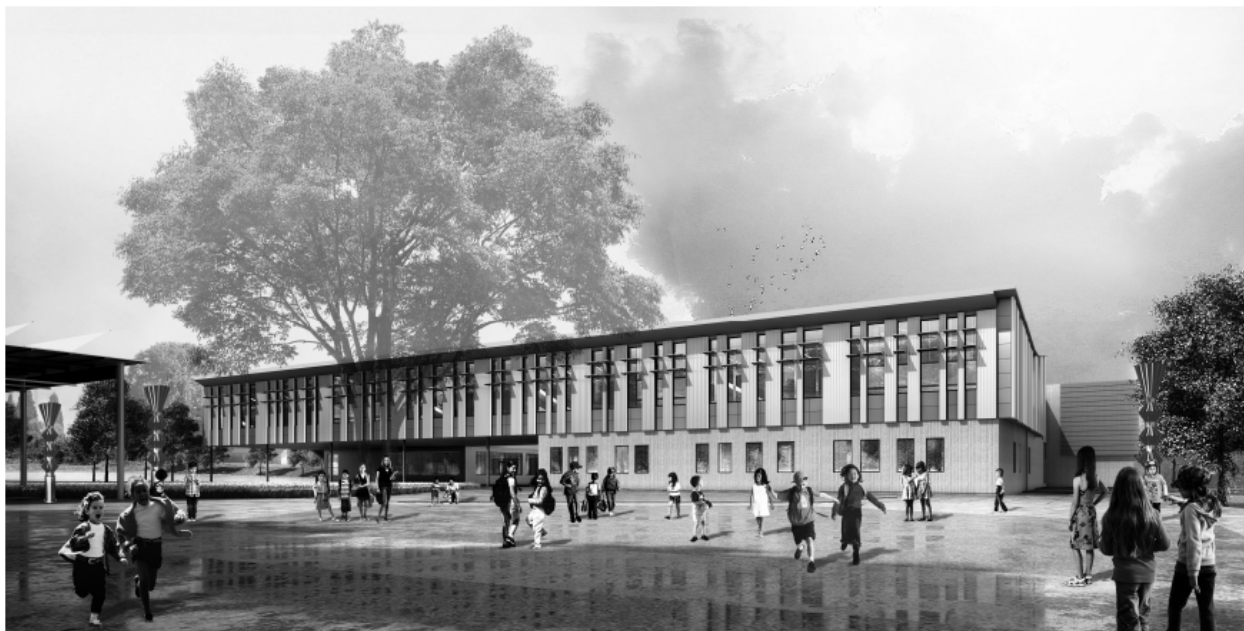
Building Description (separated by construction phases)

The new elementary school replaced the original school built in 1960. This new building includes classrooms, cafeteria, gymnasium and covered play area. The structure consists of steel framing, precast concrete wall panels and reinforced masonry walls. This building was designed for seismic risk Category IV.

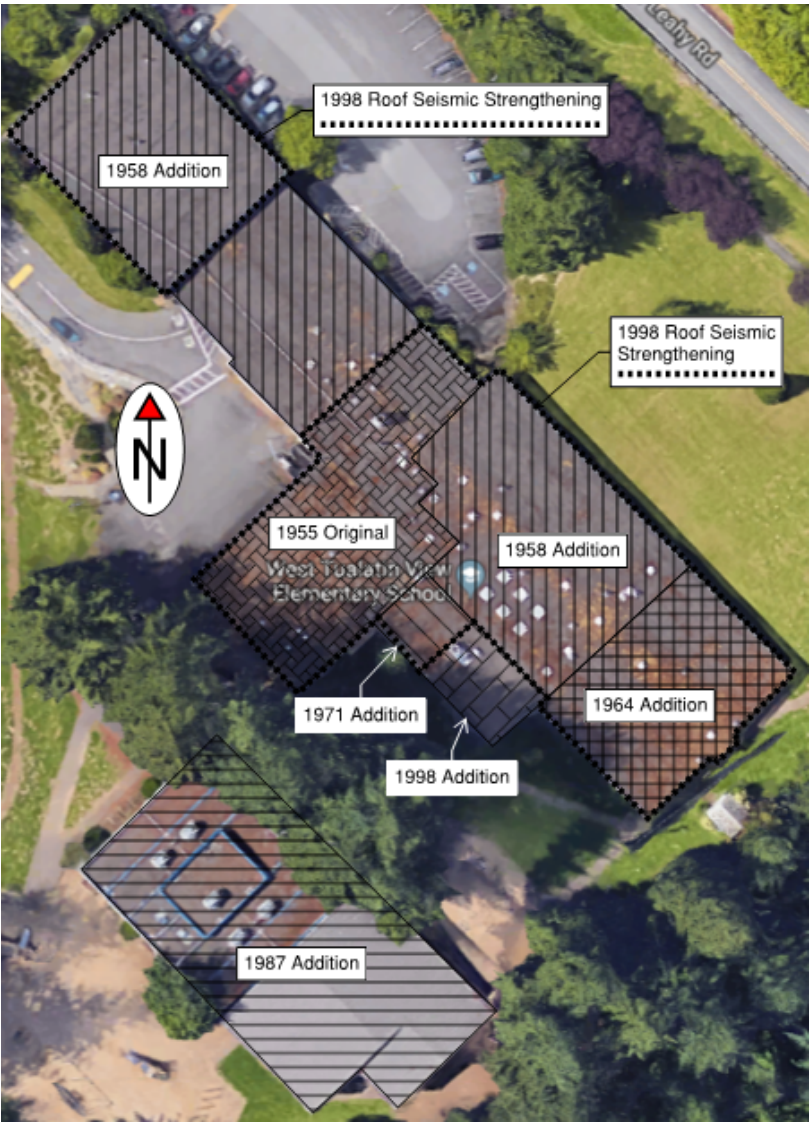
Building Description (separated by construction phases)

The original 1955 building includes a basement and main floor level. There are a relatively large number of classrooms on the main level and a large playroom area in the basement, as well as a crawl space and boiler room. The gravity elements for the original structure include primarily wood bearing walls with a small central core of masonry walls. These masonry walls are the primary lateral force-resisting system for the structure. Wood shear walls were later added during the 1998 addition/lateral upgrade. The floor diaphragm has plywood sheathing, while the roof diaphragm has straight wood sheathing.

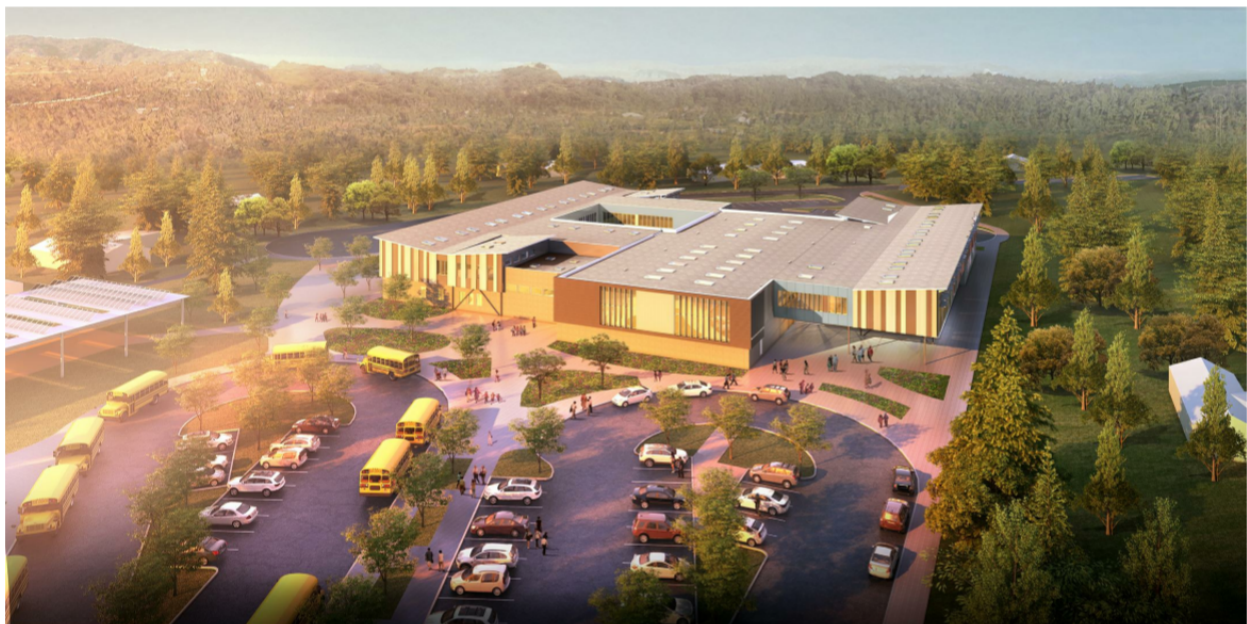
Building Description (separated by construction phases)

The new elementary school replaced the original school built in 1960. The new school includes classrooms, a cafeteria, gymnasium, and covered play area. The structure consists of steel framing, precast concrete wall panels, and reinforced masonry walls. This building was designed for seismic risk Category IV.

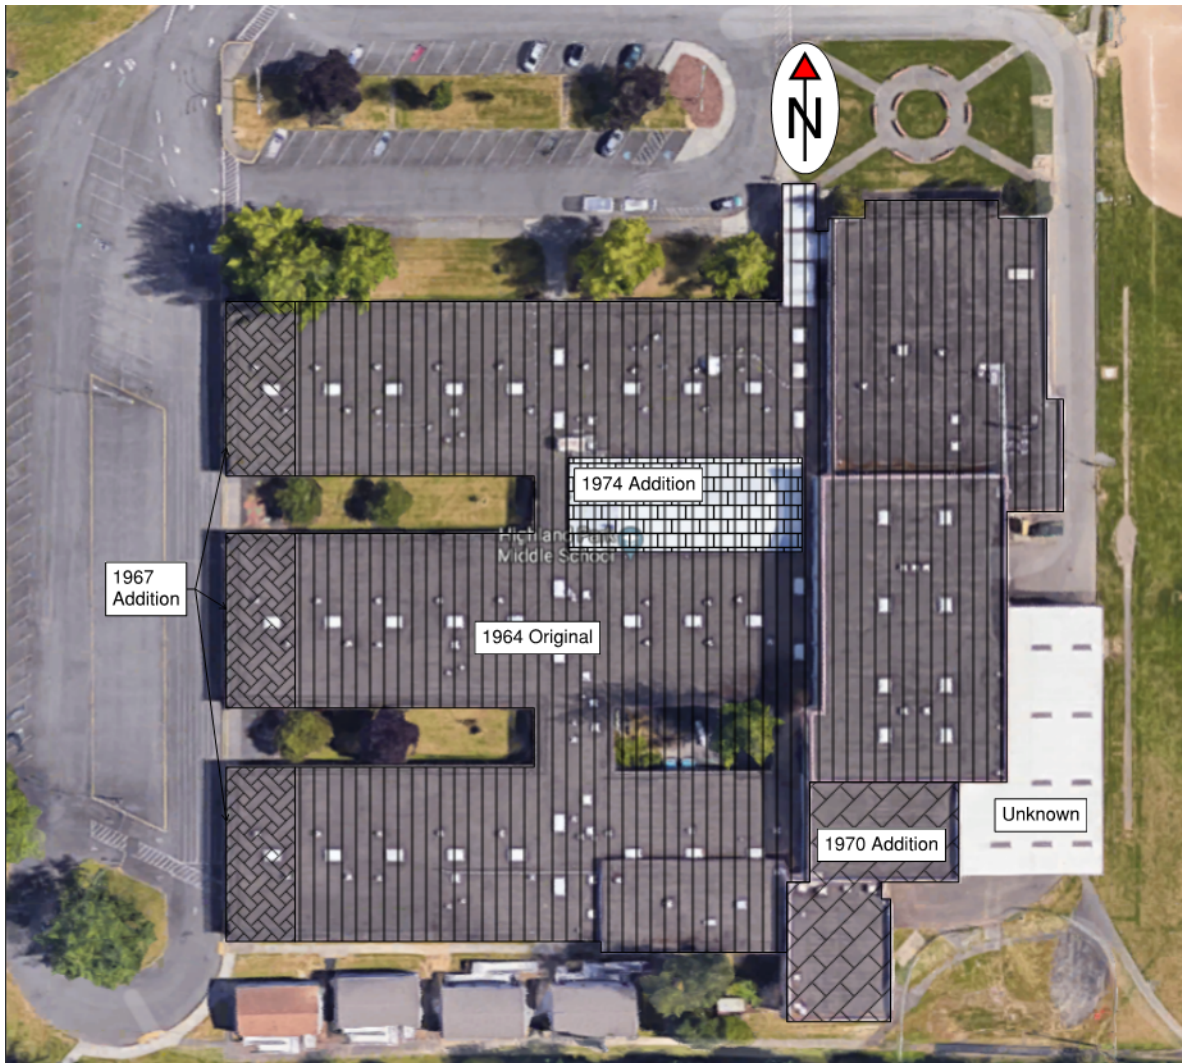
Building Description (separated by construction phases)

The original 1964 construction and later additions are well documented and consistently use the same building scheme between the four middle schools listed:

The lateral structure consists of perimeter tilt-up concrete walls spanning between steel columns and concrete pilasters. Interior wood bearing walls are not explicitly sheathed for any lateral performance. Foundations are typical concrete strip footings with concrete stem walls that extend up to meet either concrete or wood stud walls. Floor structure is reinforced concrete slab-on-grade with no direct connection to any foundation or stem walls. The diaphragm is typically connected to shear walls for in-plane load transfer but lacks adequate connections for out-of-plane loading. The classroom wings contain plywood diaphragms while the gymnasium and 1970 addition contain Tectum sheathing.

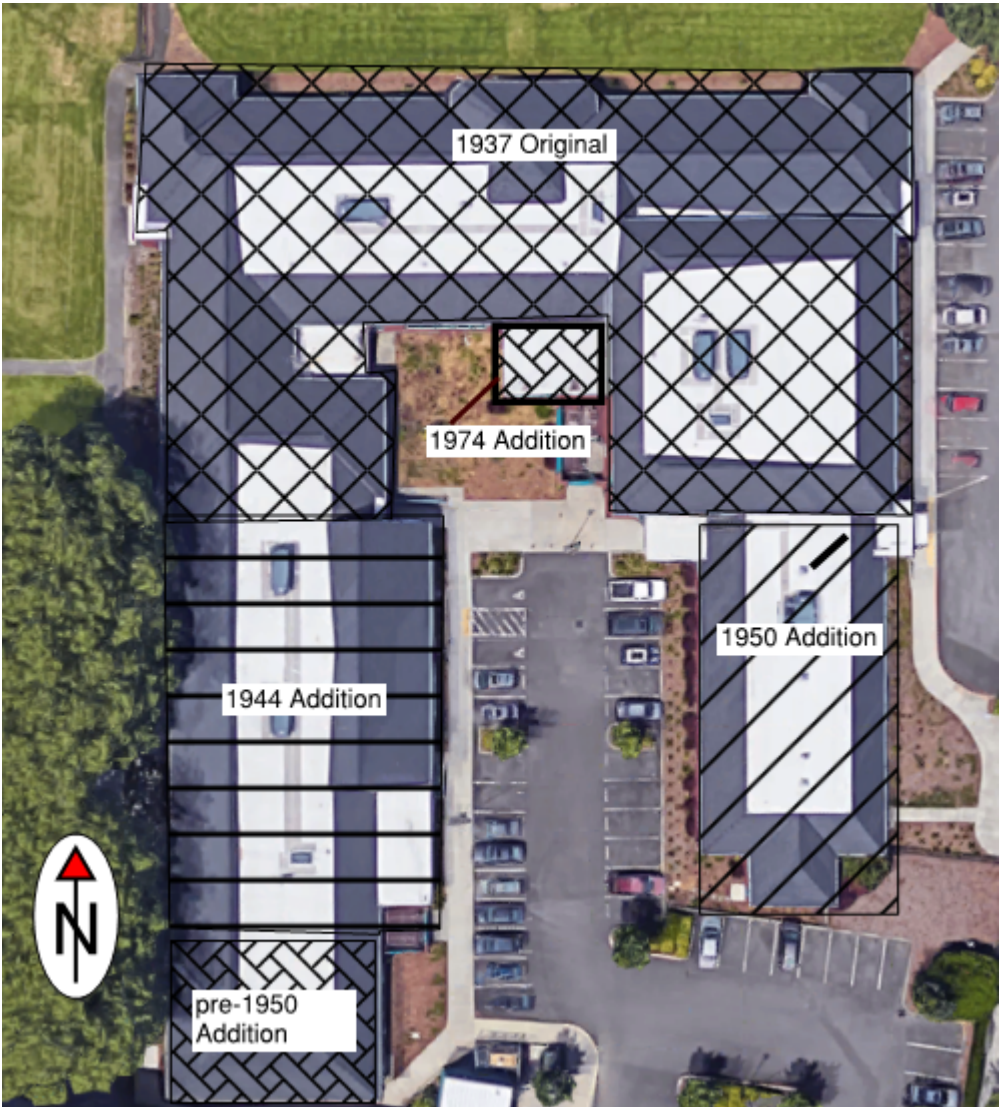
The primary lateral system for this structure is wood framed construction (W2) with one building wing consisting of unreinforced masonry (URM) bearing walls. The roof diaphragm is a flexible plywood roof.

Building Description (separated by construction phases)

The original 1937 building is a single-story structure containing classrooms and offices. The gravity system consists of timber roof truss on interior and exterior wood bearing walls. Exterior walls have brick veneer. The wood walls are supported by reinforced continuous concrete footings. The first floor is 2x joist construction supported by beams and posts. The posts are supported by unreinforced concrete spread footings. The original lateral system of the original building used 1x6 sawn sheathing at the roof diaphragm, and 1x6 wall sheathing at the walls. Orientation of the sheathing planks is unknown.

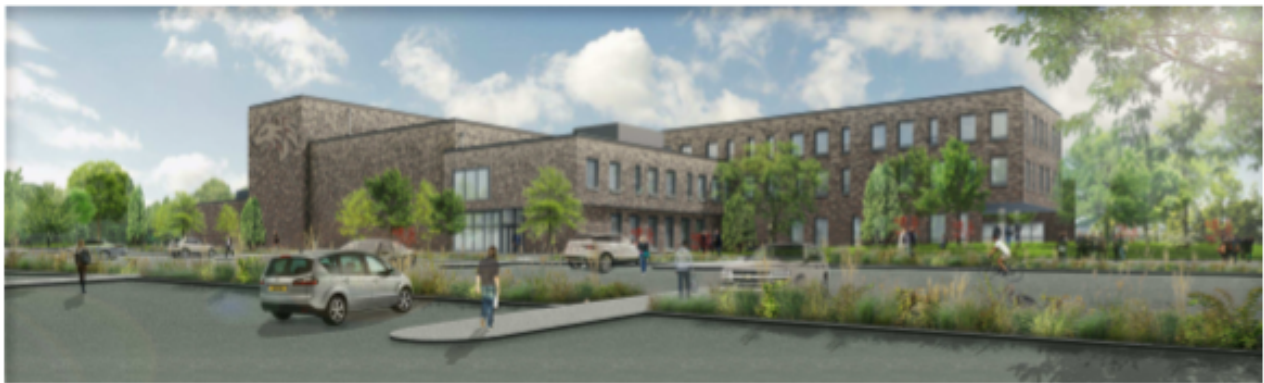
Building Description (separated by construction phases)

The structure consists of steel framing and precast concrete wall panels. This building was designed for seismic risk Category IV.

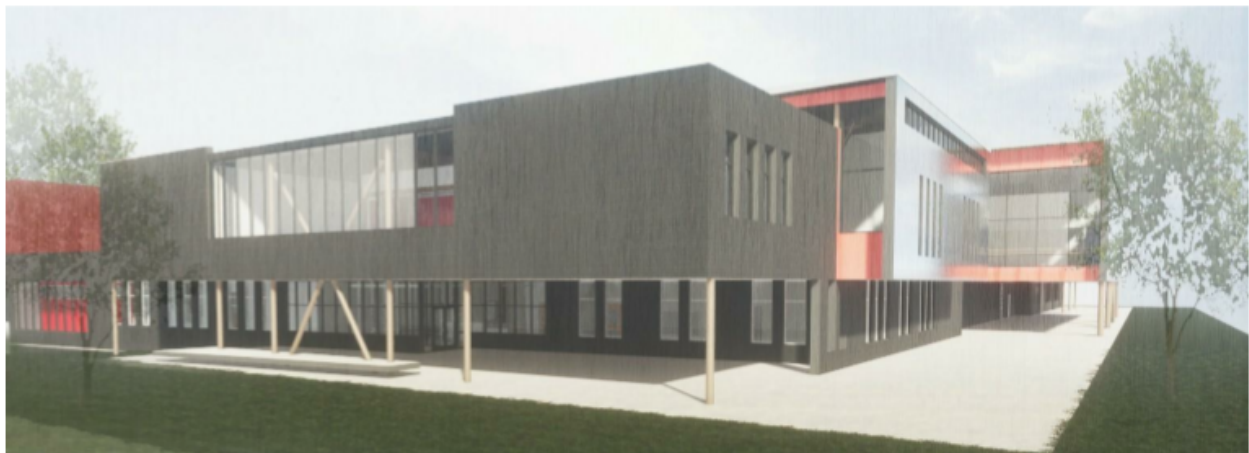
Building Description (separated by construction phases)

A new school building is to be constructed in 2019 replacing the building originally constructed in 1948. The 2009 Performing Arts Center is to remain. The new structure will contain classrooms, a large commons area, and a kitchen. The new building will connect to the Performing Arts Center that was built in 2009 and designed by James G. Pierson structural engineers. The 2009 building was designed for a seismic risk Category III and the 2019 building is being designed for seismic risk Category IV.

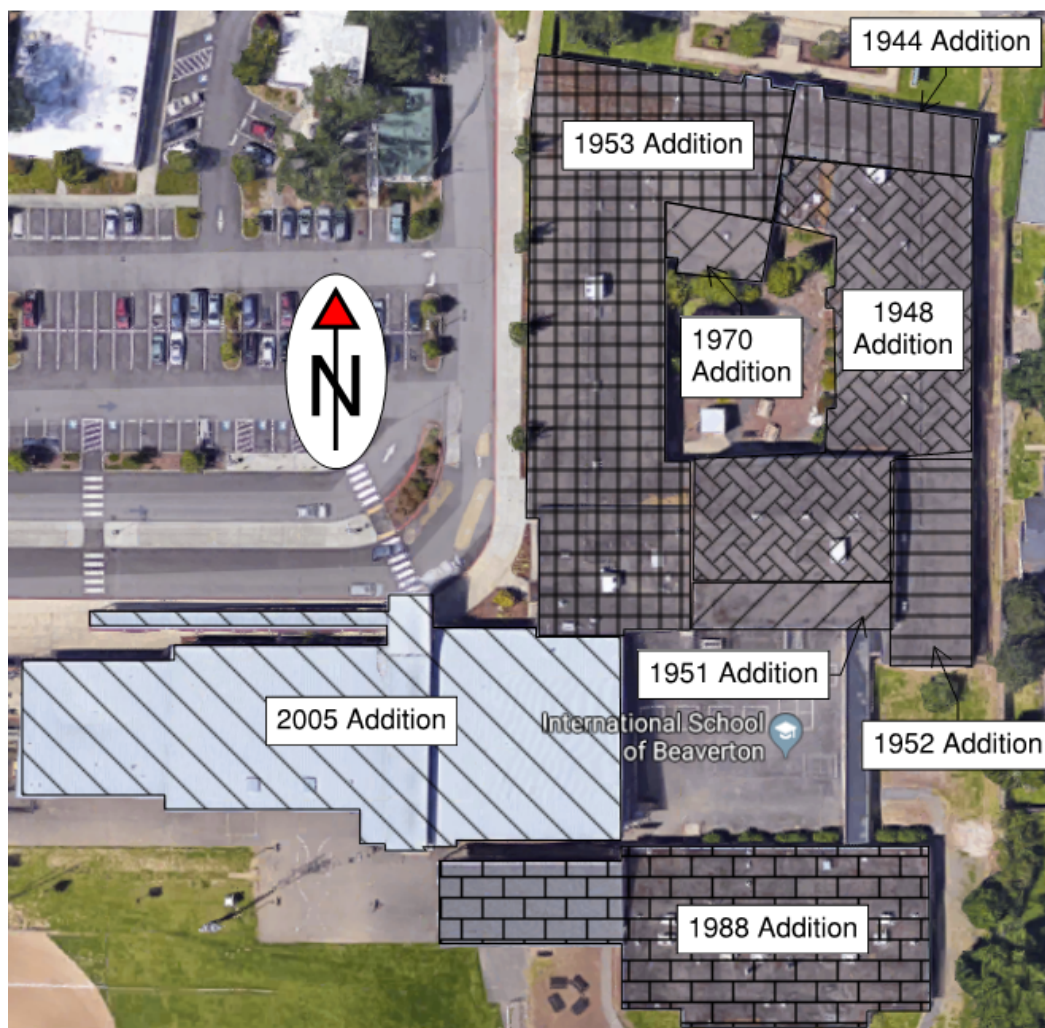
Building Description (separated by construction phases)

The 1944 addition is single-story building constructed of concrete strip footings, straight sheathed wood shear walls, and a shiplap diaphragm. There is a crawl space under the first floor in both the hallway and in the classrooms. The first floor is constructed of wood joists spanning between the strip footings and supporting a plywood deck. All of the brick along the exterior is nonloadbearing and acts only as a veneer. There is a URM parapet around the original front entry of the building on the north side.

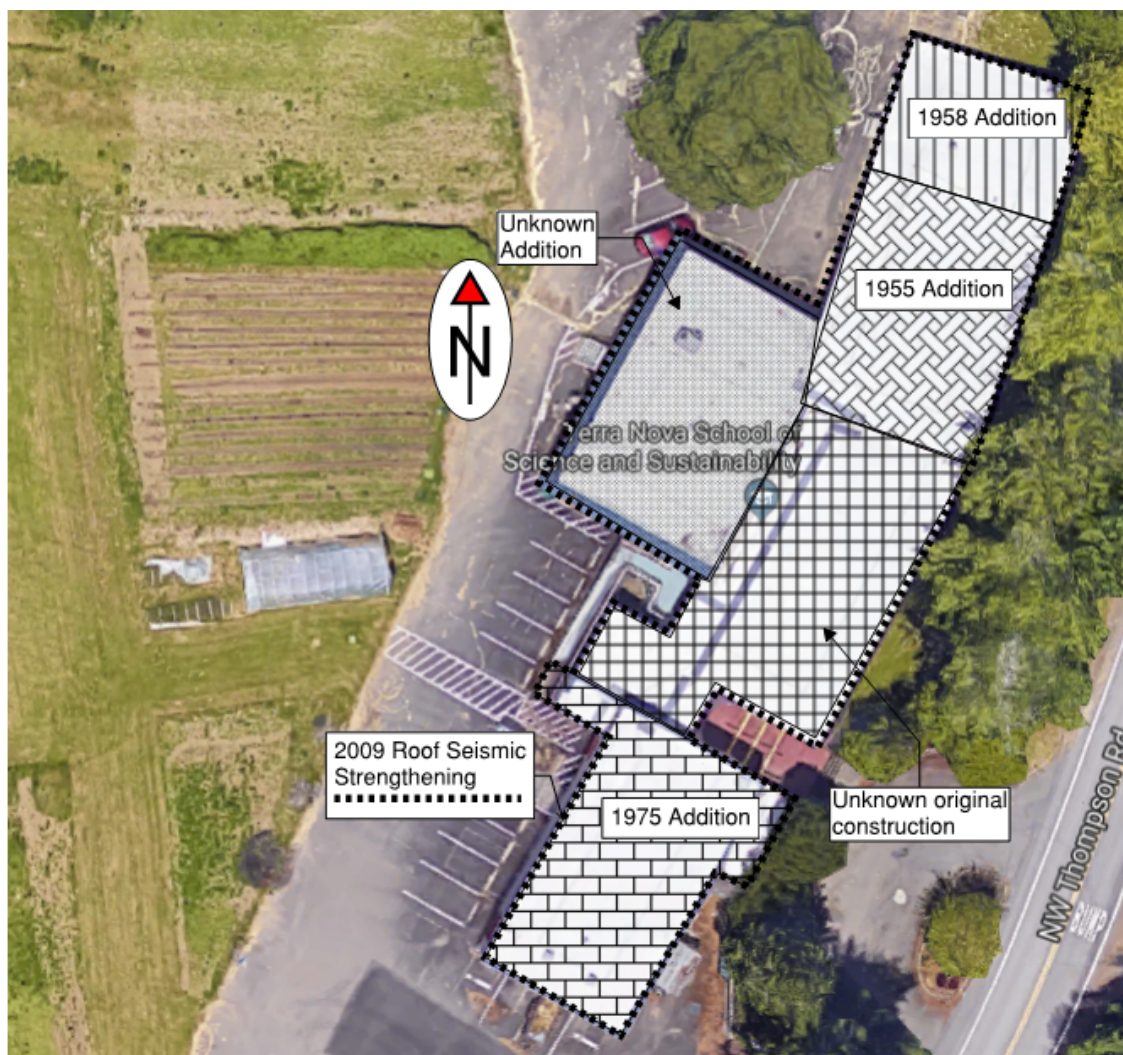
Building Description (separated by construction phases)

The original building was observed to be similar to the 1955 and 1958 additions. These additions have strip footing foundations and a concrete slab-on-grade. The strip footings support wood shear walls. The shear walls are tied into the footings with steel anchors and attached to the roof diaphragm. There was a wall infill for the covered roof over the hallway, but drawings were not available during this review. It is assumed that the structure is a wood wall infill similar to the construction of the rest of the building.

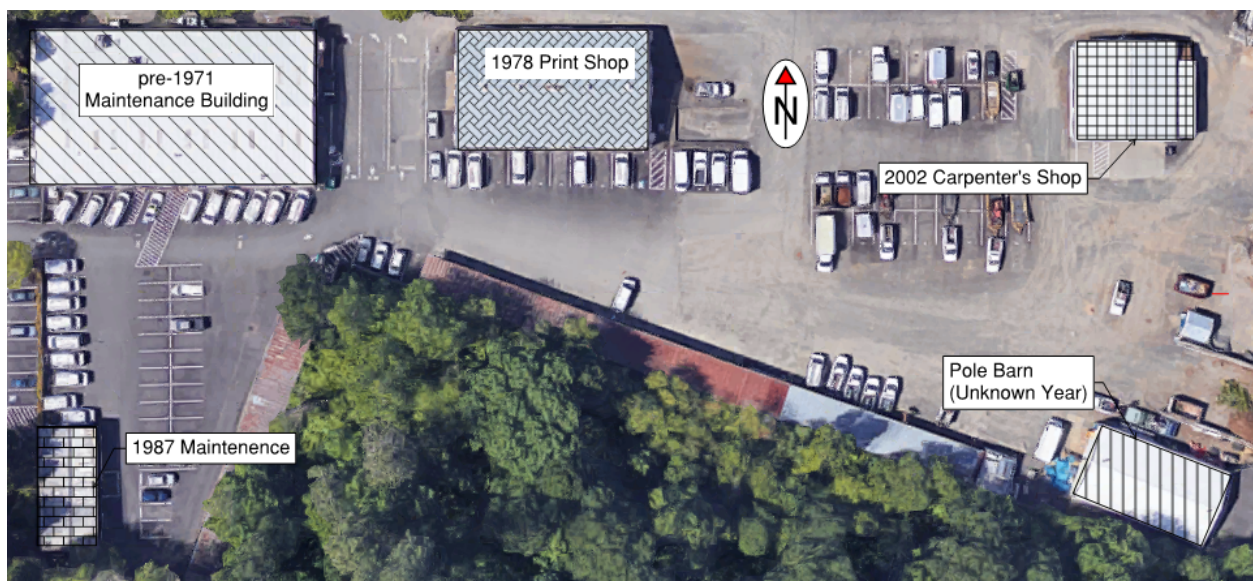
Building Description (separated by construction phases)

Built prior to 1971, the maintenance shop is a single-story steel warehouse (S2). The roof is a steel deck supported on steel beams and plate girders. The plate girders are supported by tapered plate columns. The building is laterally braced with steel tension braces at the exterior walls in the long direction and steel moment frame (plate girders) in the short direction. The first floor is a slab-on-grade. Foundation elements are unknown.

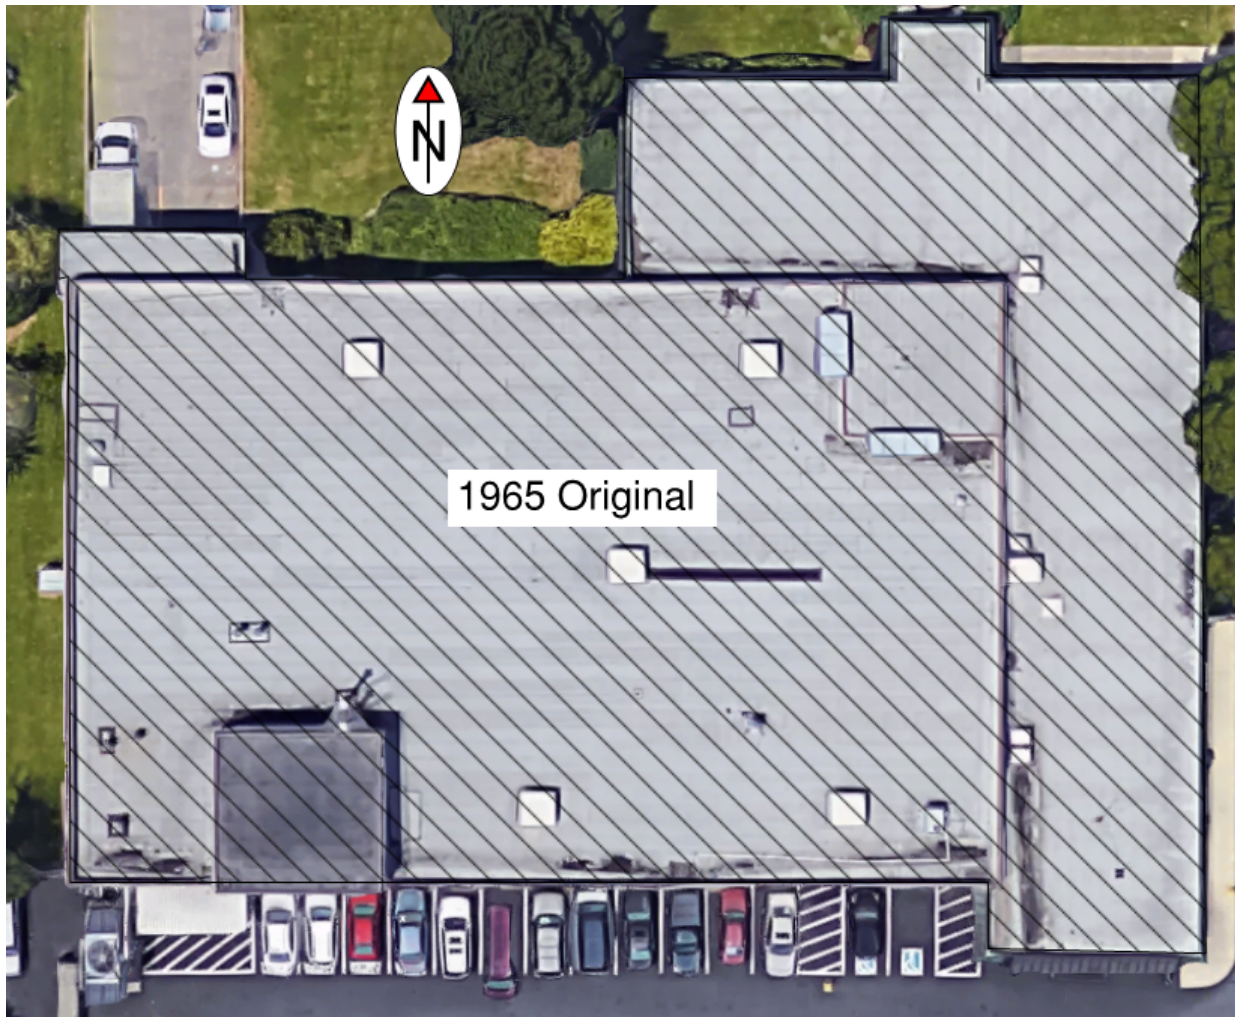
Building Description (separated by construction phases)

The Transportation 5th St. South building was constructed in 1965 as a print shop. This is a single-story structure that encloses a warehouse space and several offices. The roof consists of metal deck on steel wide flange beams. These beams are supported by steel girders. These girders are supported by interior steel columns and exterior CMU pilasters. The exterior of the building is constructed with reinforced CMU walls (RM1). The columns are supported by concrete spread footings, and the CMU
